**BRIDGER AND CENTENNIAL BUILDINGS  
225 BRIDGER AVE-310 SOUTH 3<sup>RD</sup> STREET  
LAS VEGAS, NEVADA  
AUGUST 18, 1999**

ASBESTOS BULK  
SAMPLE SURVEY

BRIDGER BUILDING  
225 BRIDGER AVENUE  
CENTENNIAL BUILDING  
310 SOUTH 3RD STREET  
LAS VEGAS, NEVADA

Converse Project No. 99-43324-07

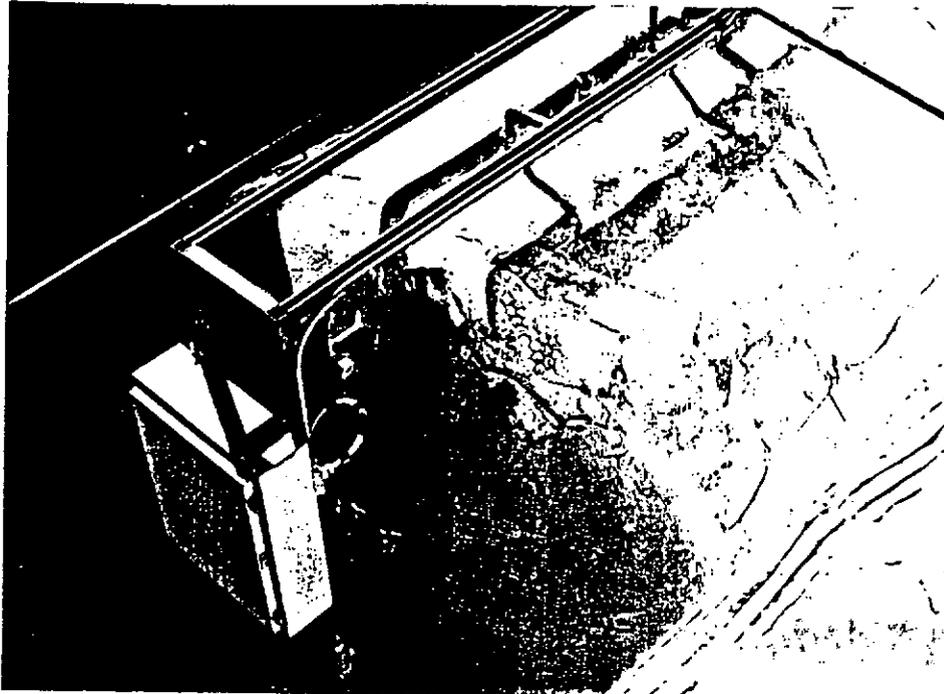
Figure 1. Penthouse Mechanical Area: Top View of Damaged Water Storage Tank Insulation.

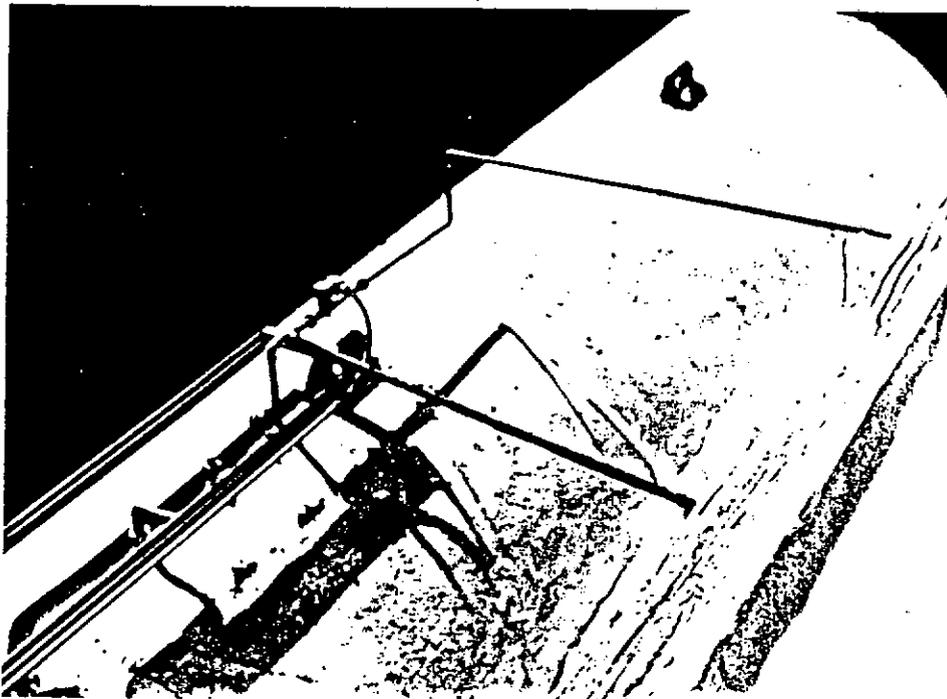
Figure 2. Penthouse Mechanical Area: Top View of Damaged Water Storage Tank Insulation.

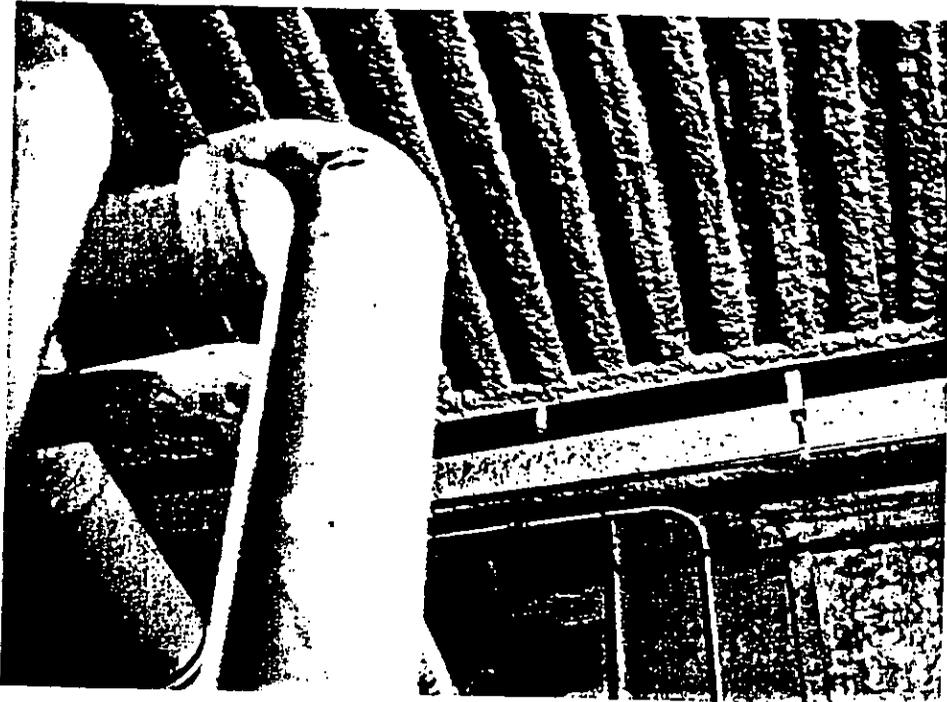
Figure 3. Penthouse Mechanical Room: View of Piping Insulation and Ceiling Deck Fireproofing.

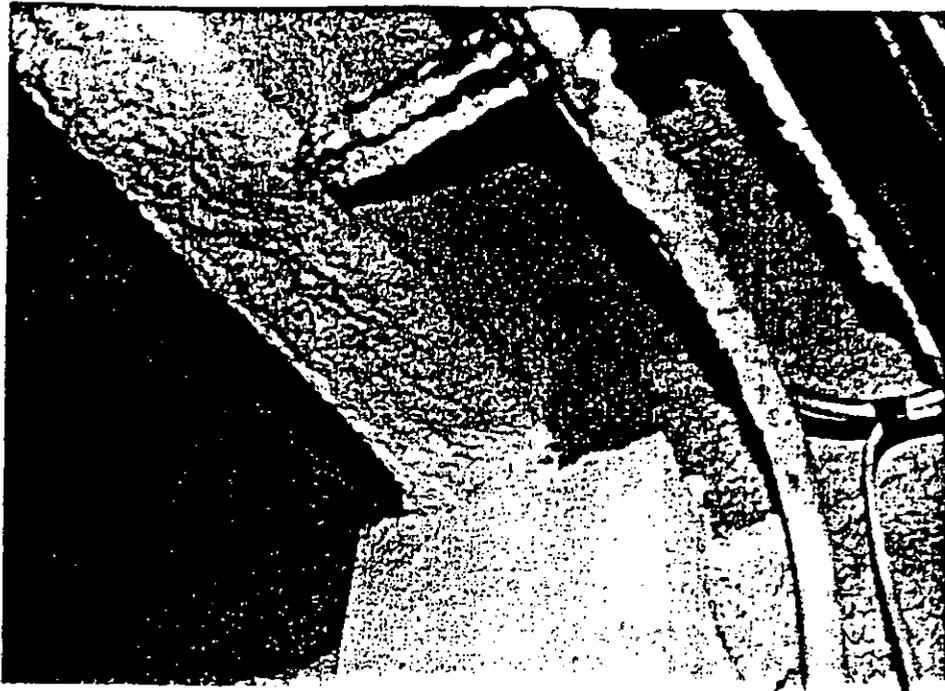
Figure 5. Penthouse Mechanical Room: View of Ceiling Deck Fireproofing

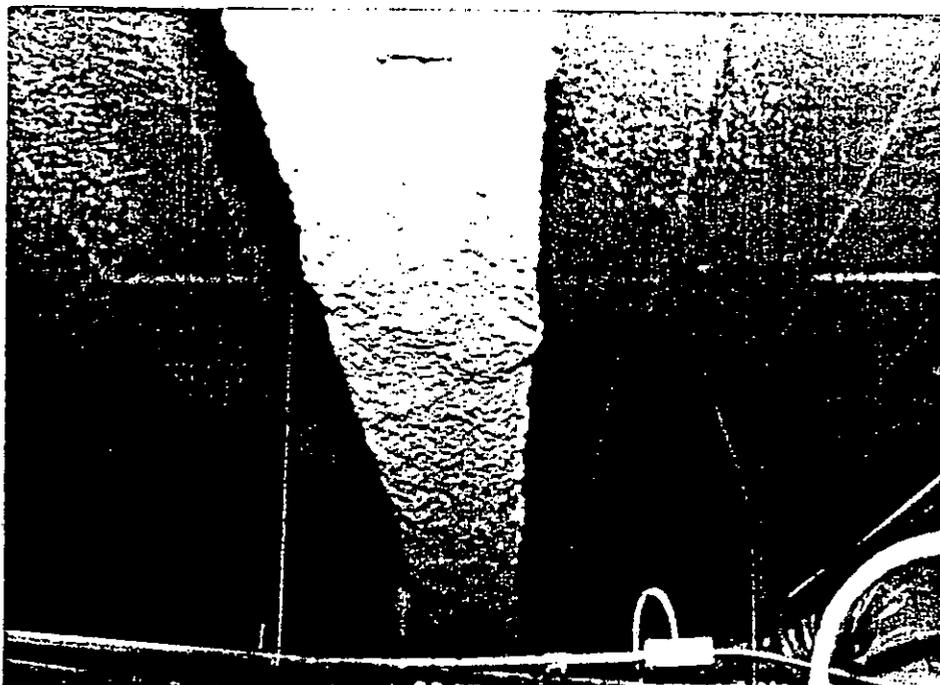
Figure 6. Typical Fireproofing on Structural Members With Over-spray on Associated Surfaces (Located Above Suspended Ceiling Panels).

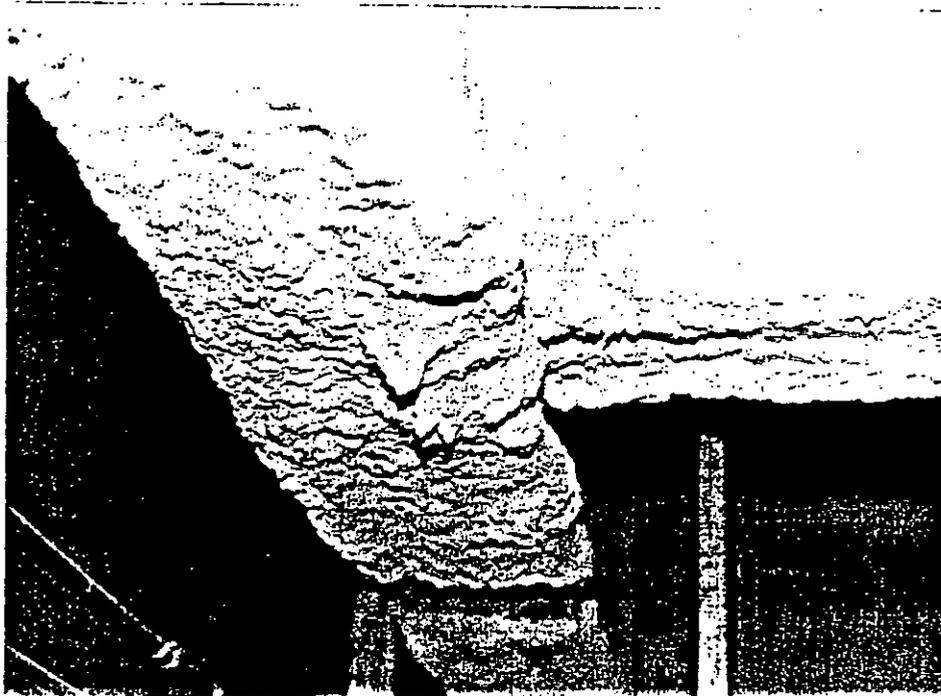
Figure 8. Typical Fireproofing on Structural Members (Located Above Suspended Ceiling Panels).

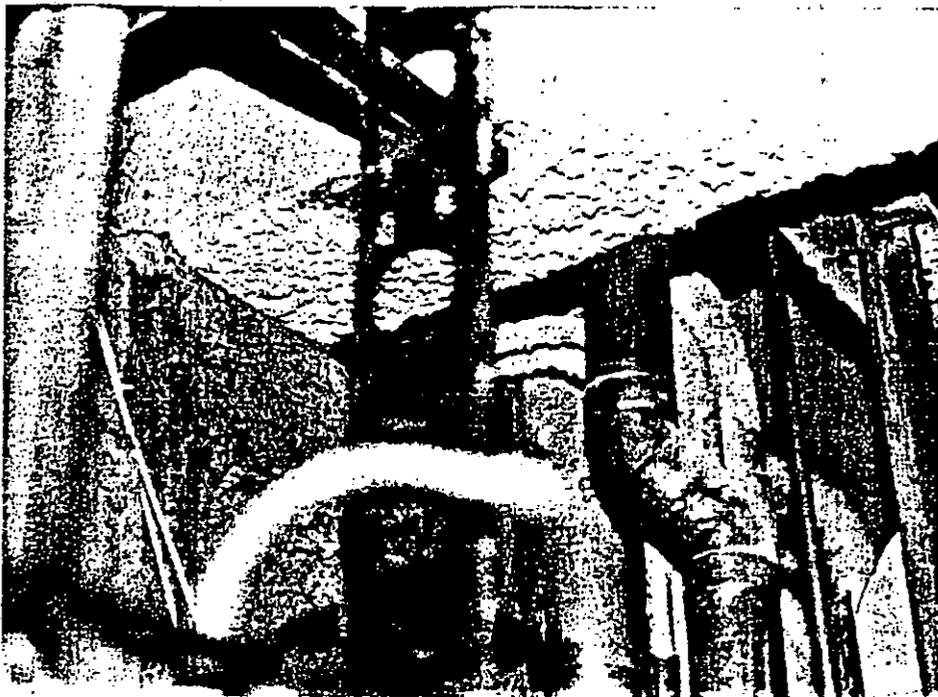
Figure 9. Typical Fireproofing on Structural Members With Over-spray on Associated Surfaces (Located Above Suspended Ceiling Panels).

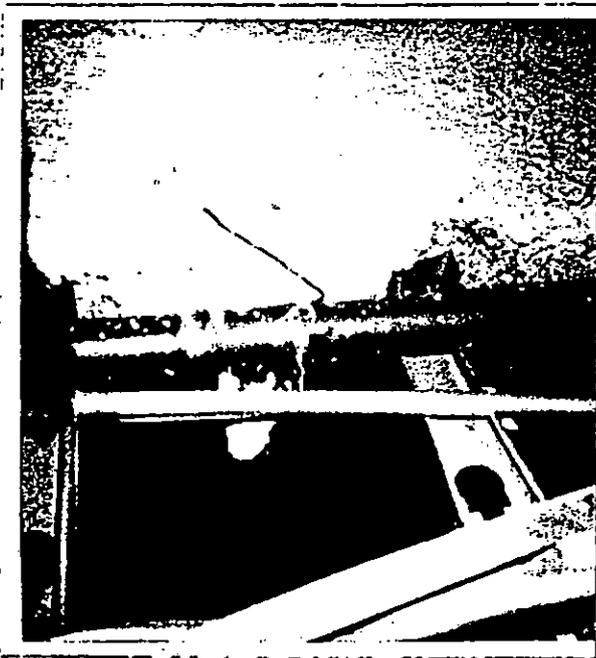
Figure #8. Eighth floor west end ceiling tiles (Fireproofed lateral I-beams).
