Converse Consultants

October 13, 2006

Subject: **Asbestos Consulting Services**
Bridger and Centennial Buildings
225 Bridger Avenue and 310 South 3rd Street
Las Vegas, Nevada

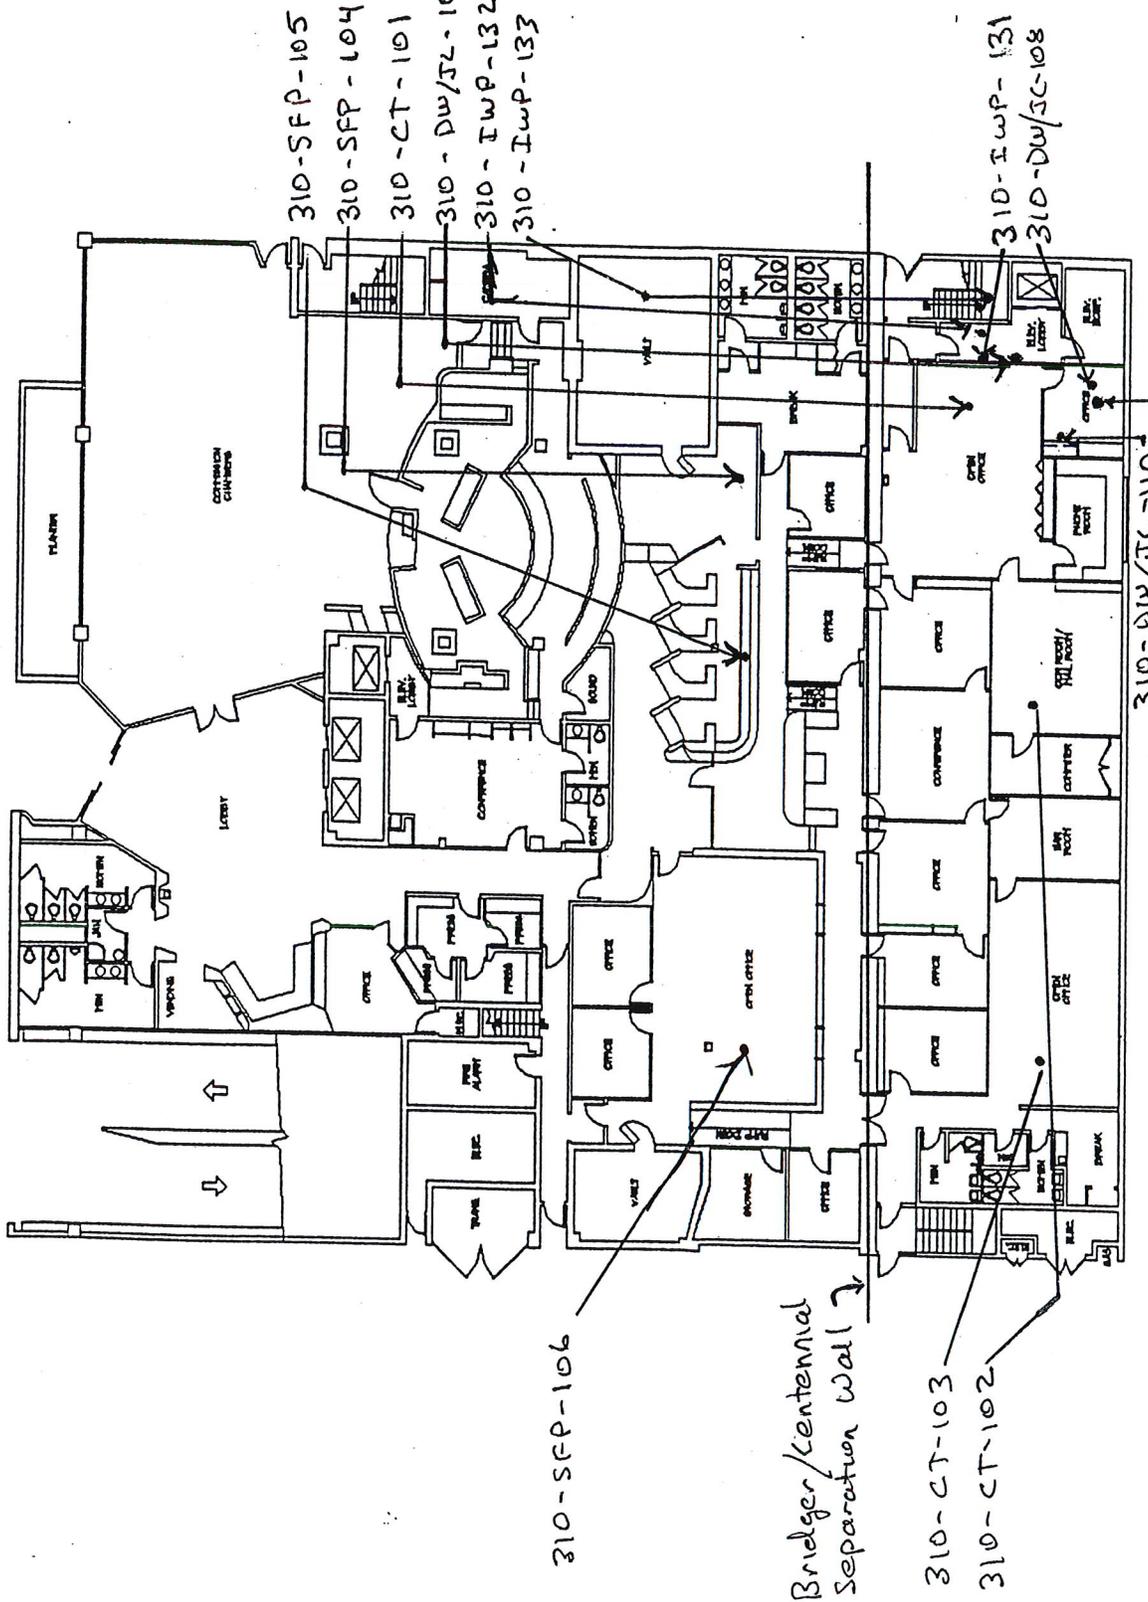
EXISTING FIRST FLOOR PLAN

310 - DW/JC-110

310 - FT-107
