Monitoring of Road Conditions and Signs

2008-2010

Clark County, Nevada and the Multiple Species Habitat Conservation Plan

Project Number: 2005-NPS-529-P

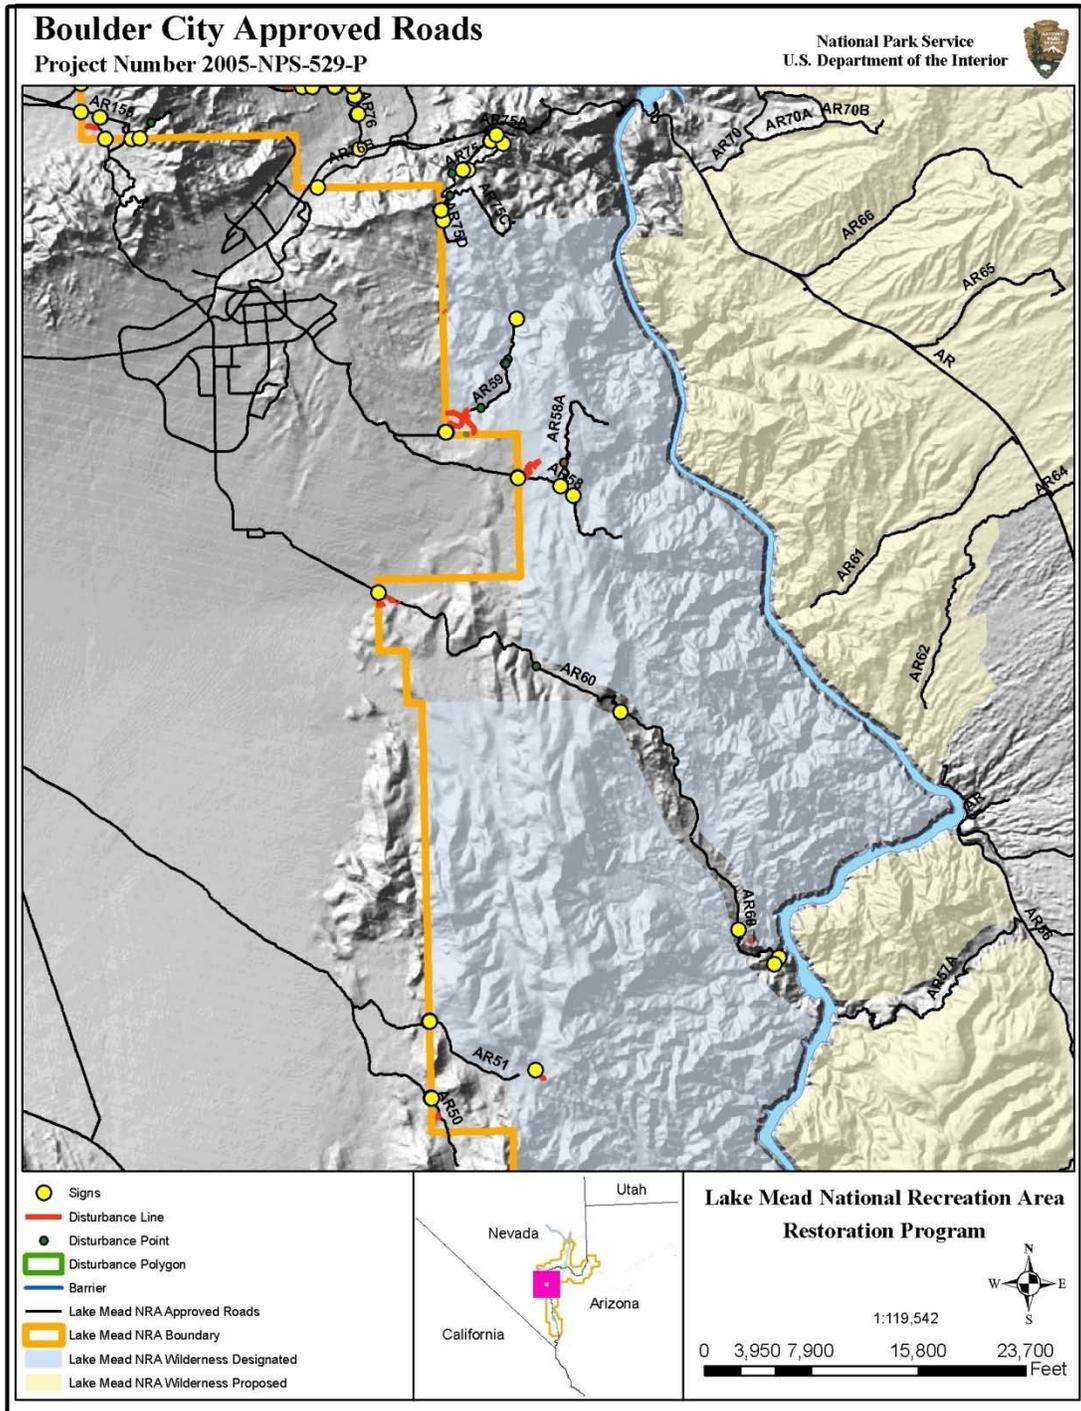
Figure 1. Map of Boulder City Region's Disturbances and Approved Roads

AR 50 (Forlorn Hope Spring Road) is a short road in the Boulder City area that follows a small wash leading to Forlorn Hope Springs on Boulder City land. Two disturbances were documented along this road. Both disturbances were associated with dirt bikes following a wash for a short while before connecting back to the approved road.

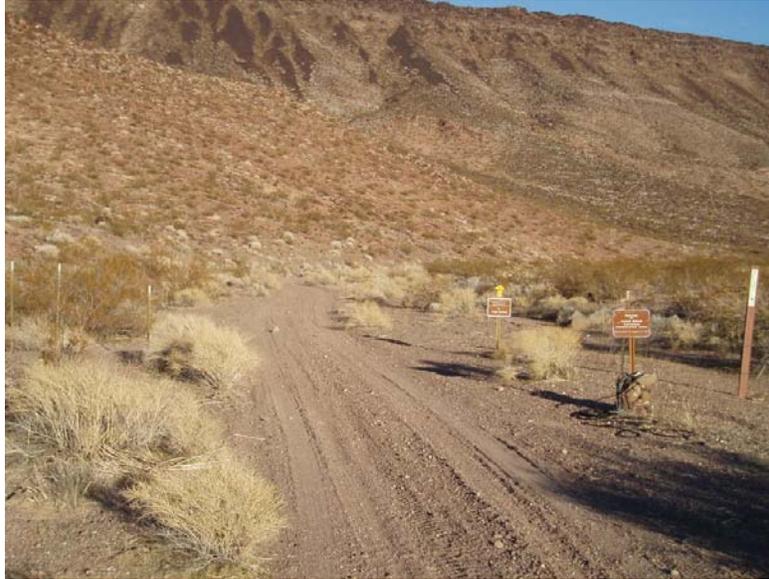
AR 051 - Yucca Camp Rd

AR 51 (Yucca Camp Road) is a popular hunting road that is cherry-stemmed into the Black Canyon Wilderness area. This road received very little use, but disturbances were high at the end of the road. Five disturbances were documented at the end of the road associated with visitors traveling past the end of the road into the mountains. There was a barrier installed at the end of the road in 2005, which was extended in 2008 to prevent visitors from traveling beyond the end of the road. Although disturbances at the end of the road decreased since the barrier was installed and extended, there was still the potential for visitors to drive around the barrier due to the flatness of the terrain.

Beginning of AR 51, looking into the park

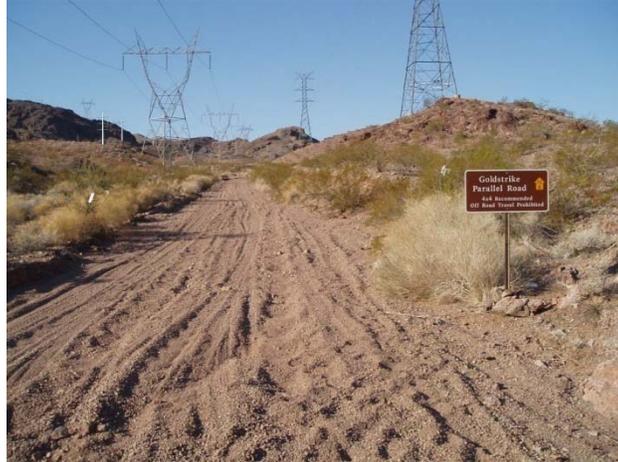
AR 075B - Goldstrike Parallel Rd

AR 75B (Gold Strike Parallel Road) is located in the Boulder City area near Gold Strike Canyon and meets up with AR75. This road is moderately rough and can easily be accessed using a 4X4 vehicle. Along portions of the road, the sides drop down into steep cliffs. During this project, no disturbance was documented on this road.

Beginning of the road at AR 75B

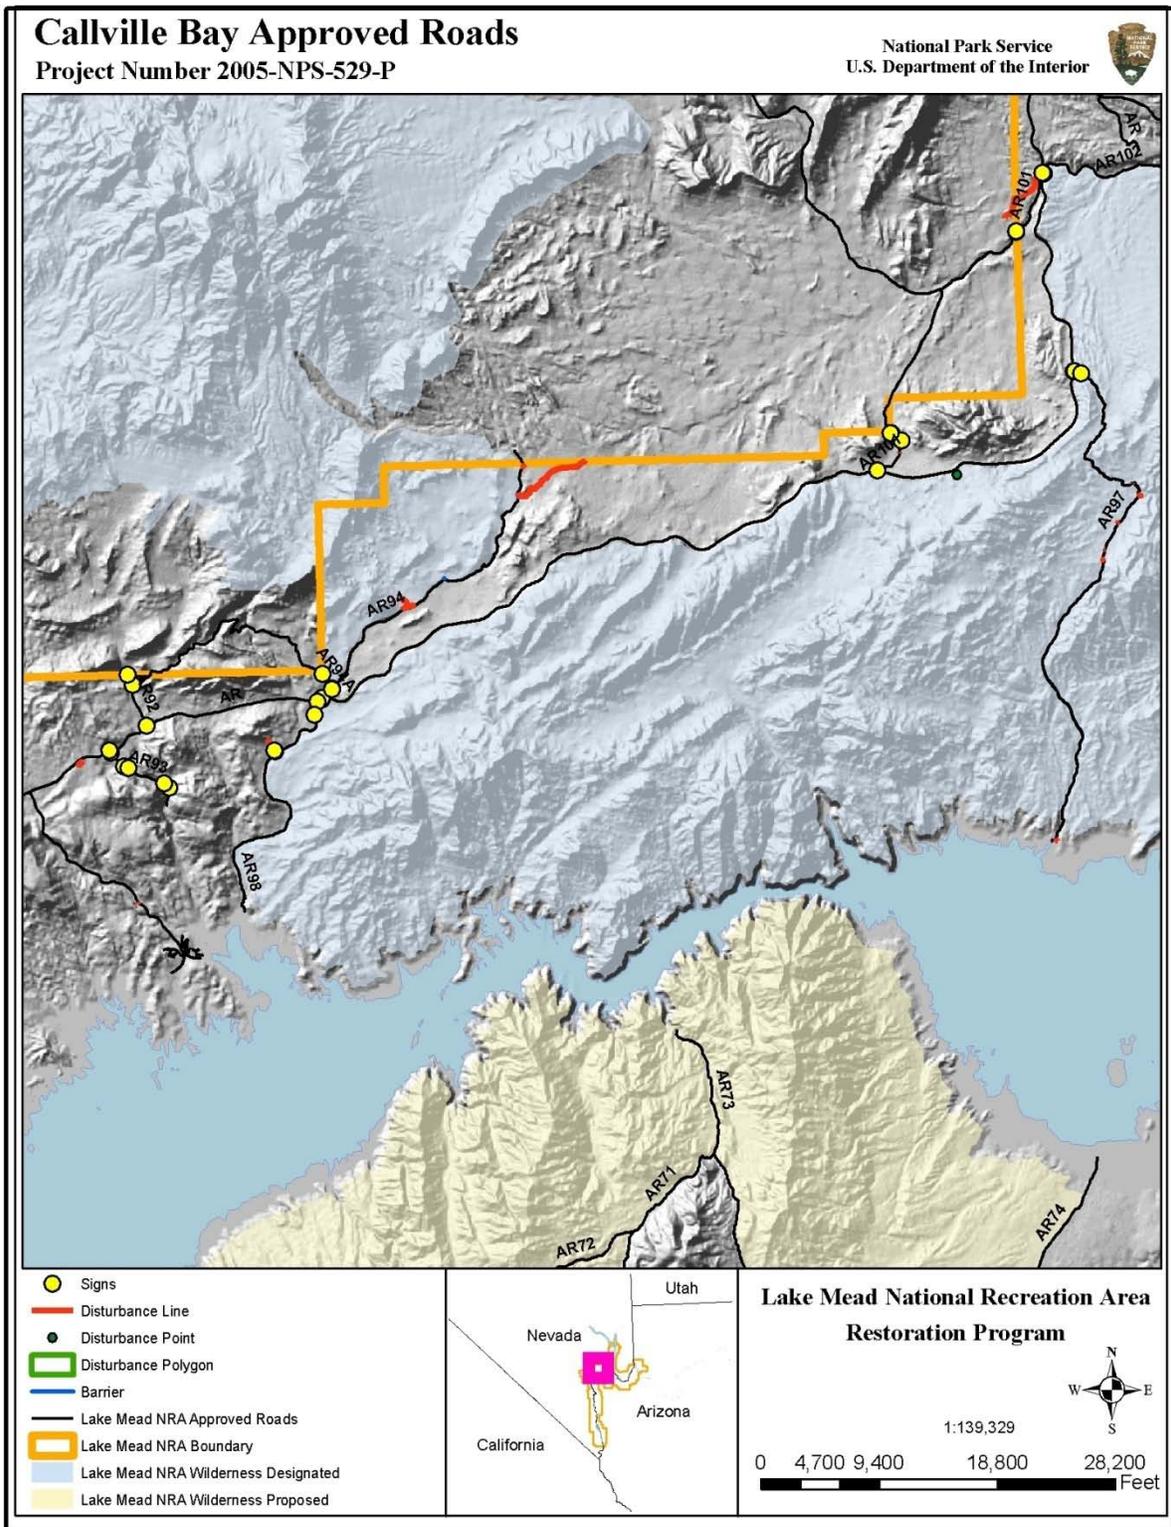
Figure 2. Map of Callville Bay Region's Disturbances and Approved Roads

AR 92 (West End Wash Road North) is located in the Calville Bay area and heads north off of Northshore road. This road is mainly in a wash. Two disturbances were recorded along this road from visitors following a wash to AR 93.

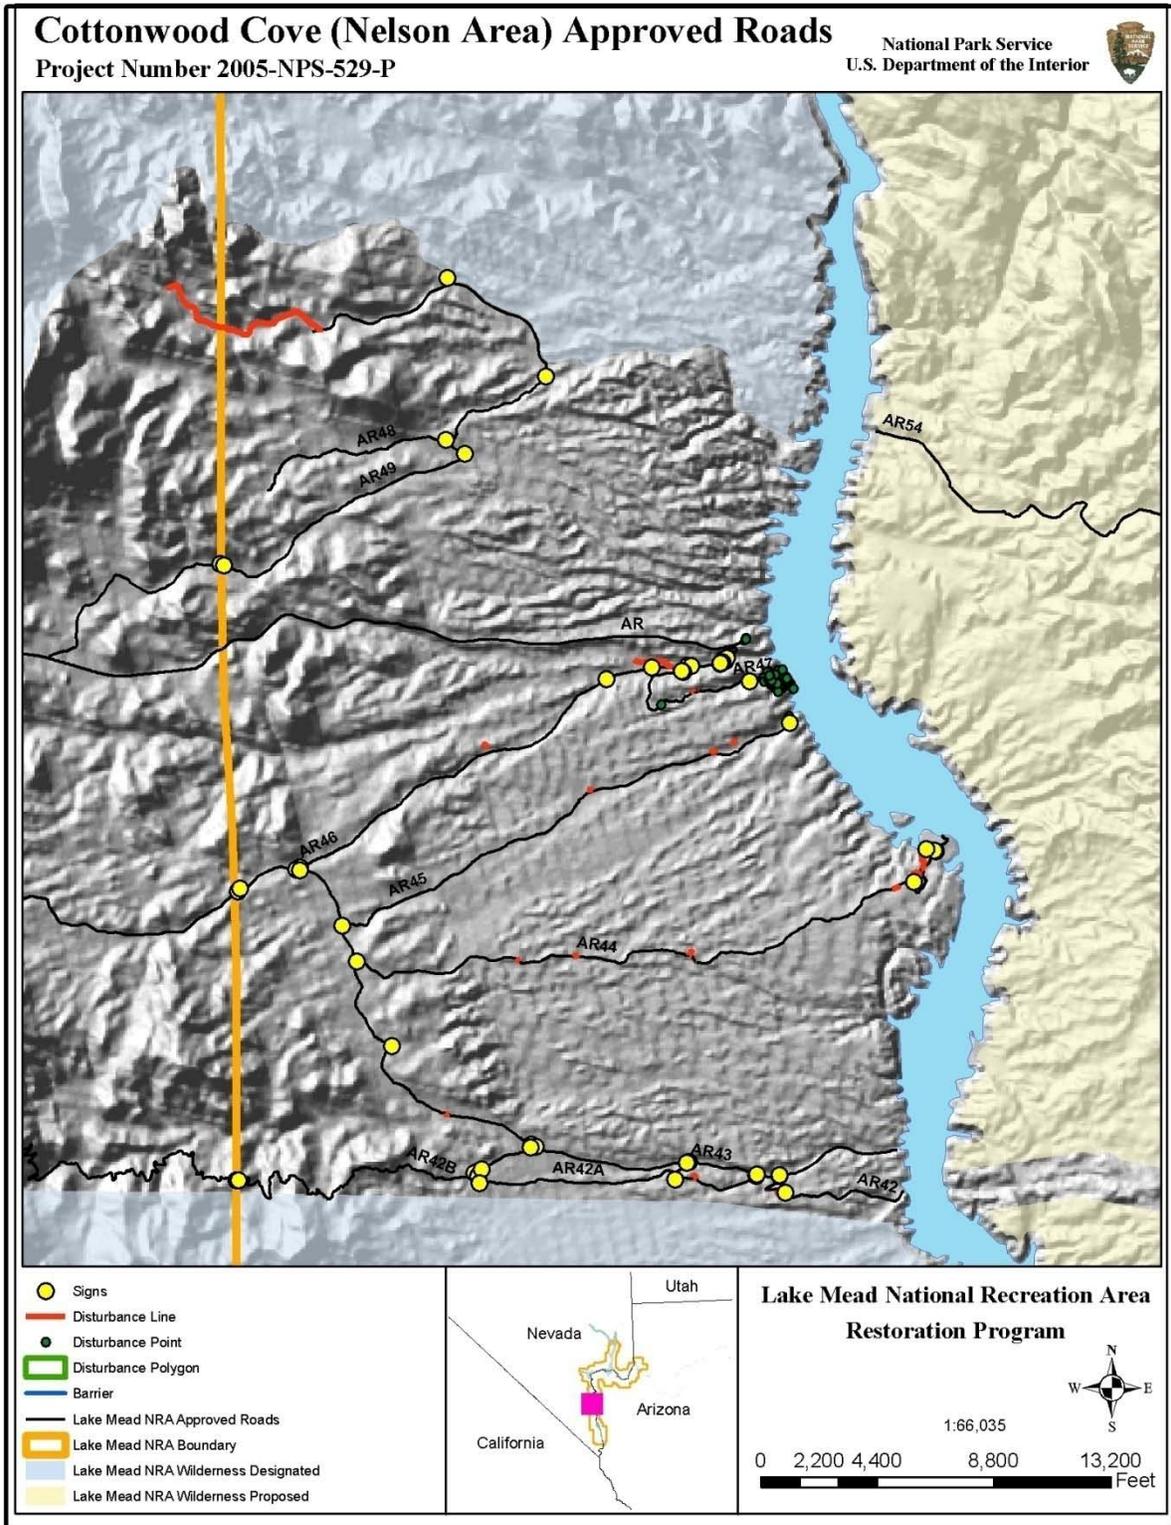
Figure 3. Map of Cottonwood Cove (Nelson Area) Region's Disturbances and Approved Roads

AR 42 (Powerline Wash Road, NV) is located in the Nelson area. The road is in a wash road that forks southeast off of AR 43. The road follows an active powerline to Lake Mohave. This is a popular swimming location. Five disturbances were recorded on AR 42. These disturbances ranged from vehicles pulling off the road to ATV users driving off into the desert. Visitors would also tag directional arrows along the road.

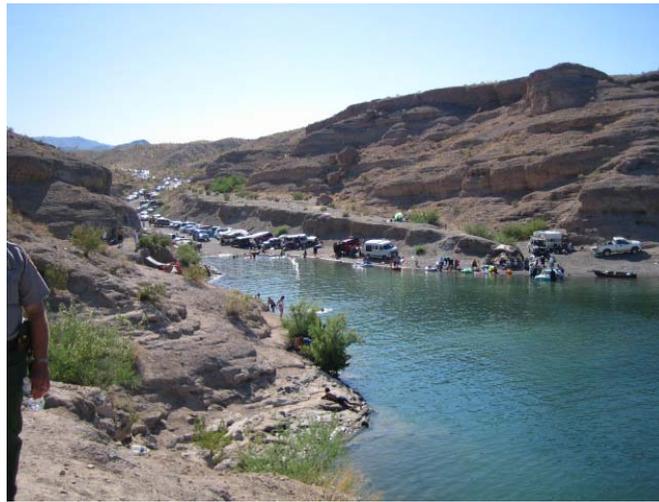
AR 047 - Placer Cove Rd

AR 47 (Placer Cove Road) is located in the Nelson area not far from Eldorado Wash. This extremely popular road provides lake access, cliff jumping, camping, and other recreational opportunities. During the summer this road was used by “beach partiers” while the rest of the year the road was used by fisherman and paddle sport enthusiasts. One hundred and sixty three disturbances were recorded on this road. The main type of disturbance was graffiti at Placer Cove. This road also received off-road vehicle disturbance and barrier breaches from both vehicle accidents and individuals purposefully removing the barriers. This road is a major problem area for the park, and in January 2010, the superintendent of Lake Mead NRA enacted new prohibitions on camping and drinking of alcoholic beverages within a one mile radius of Placer Cove.

The end AR 47 (Placer Cove) on a busy weekend

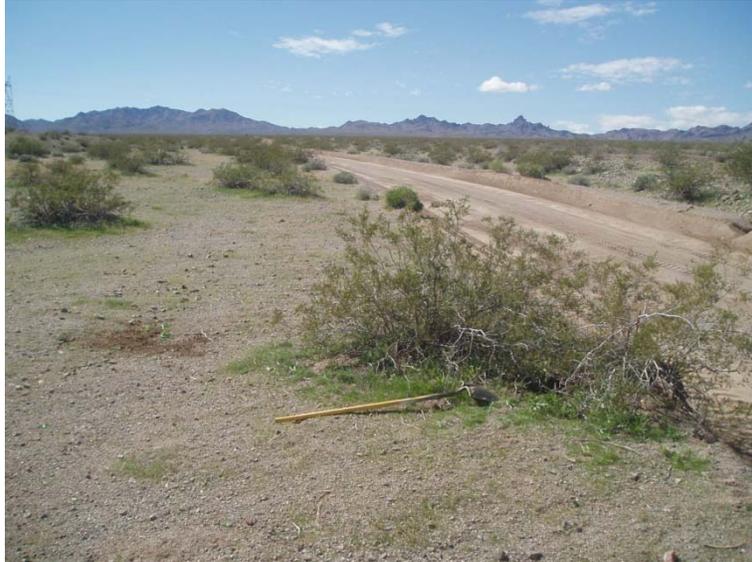
AR 023 - Nine Mile Coves Rd

AR 23 (Nine Mile Cove Road) is in the southern section of the Cottonwood Cove area where it begins off of AR 30 and follows a wash all the way down to Lake Mohave. A restroom is located at Nine Mile Cove making it a popular swimming and camping spot. This road was usually graded by the park maintenance crew. One disturbance was recorded on AR 23 where an SUV or truck performed hill climbs.

Picture looking east down AR 23

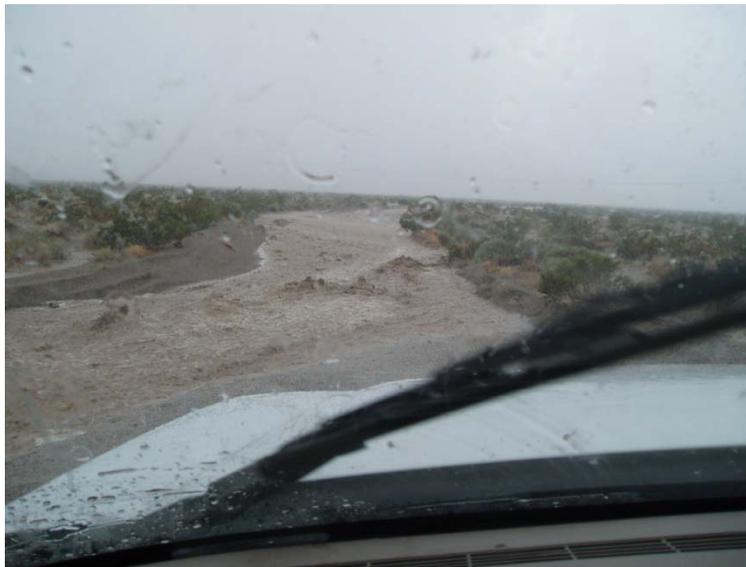
Flash flood along AR 31

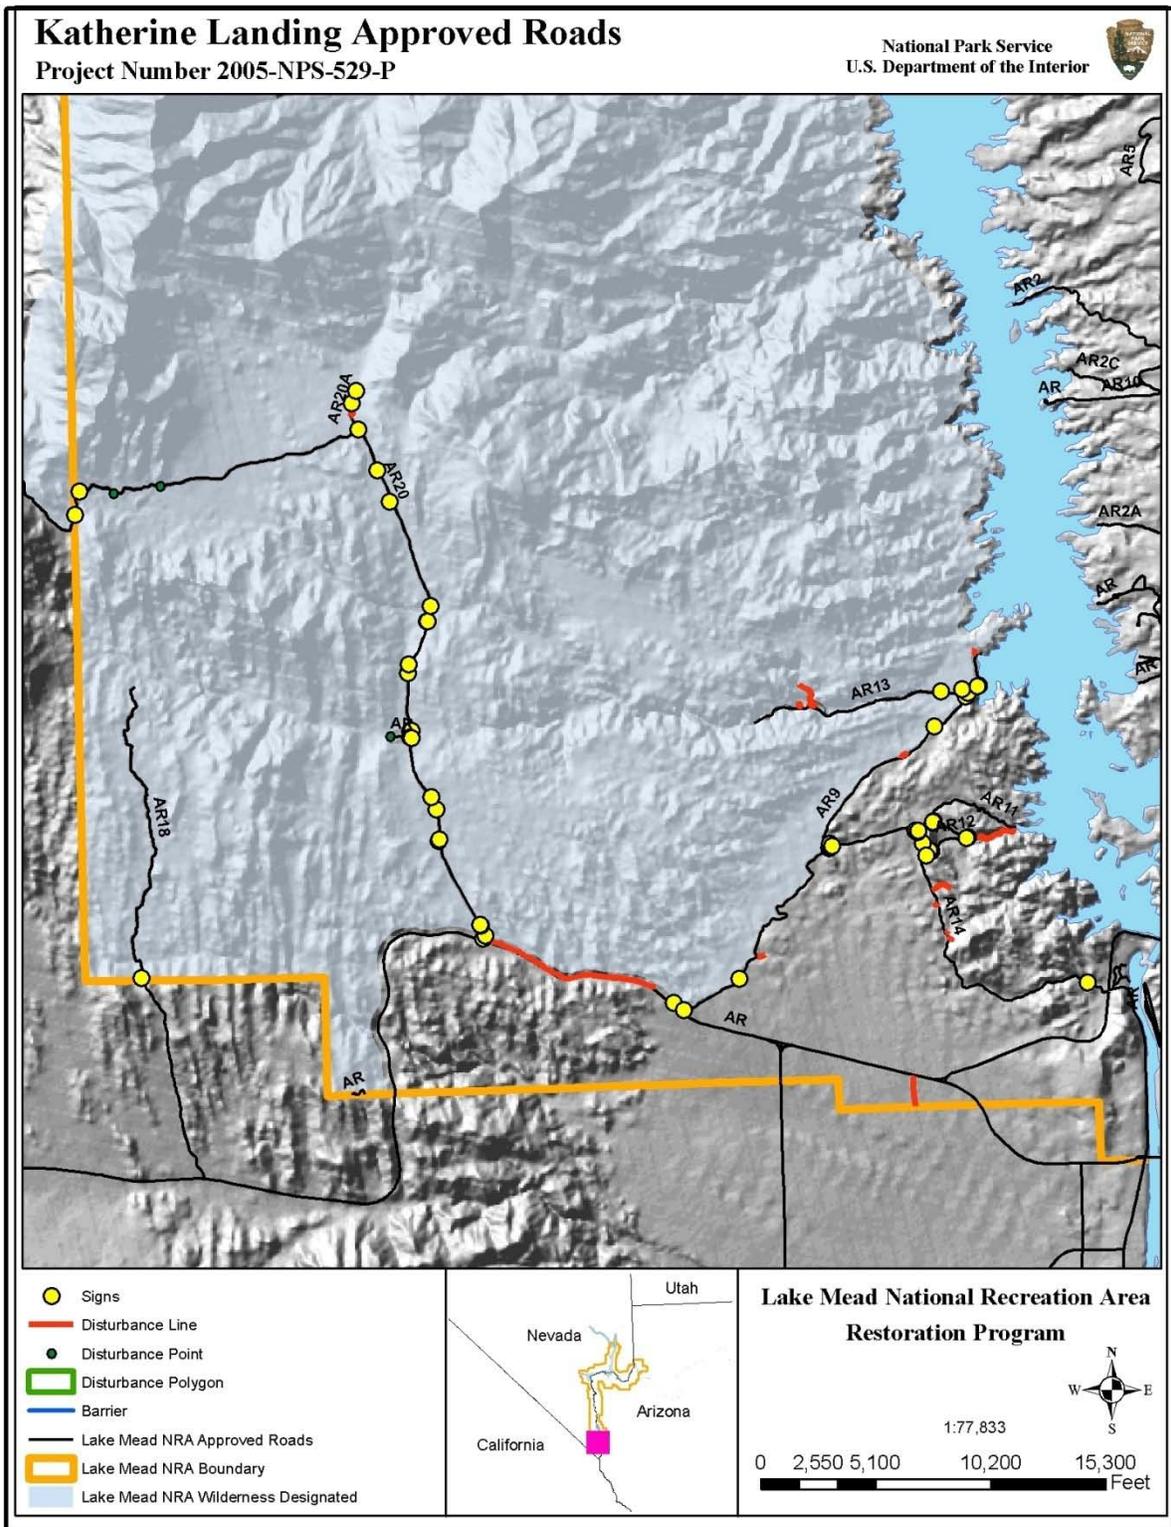
Figure 5. Map of Katherine Region's Disturbances and Approved Roads

AR 9 (Nevada Telephone Cove Road) is located in the southern section of the park near Laughlin, NV. This road goes in and out of washes, before it follows a wash down to Lake Mohave. At the end of the road is a large beach that during the summer receives large number of visitors from California, Arizona, and Nevada. Three disturbances were recorded on this road from ATVs. The major issue for this road was visitors removing wooden posts for firewood from the barrier that encircled the beach. This barrier was repeatedly repaired.

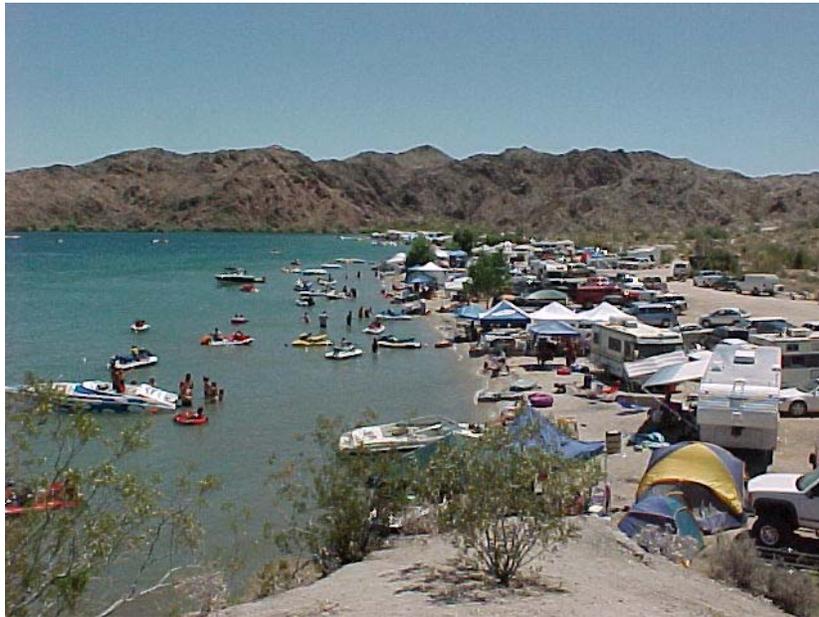
AR 009 - Telephone Cove Rd

Picture of AR 09 during Memorial Day Weekend

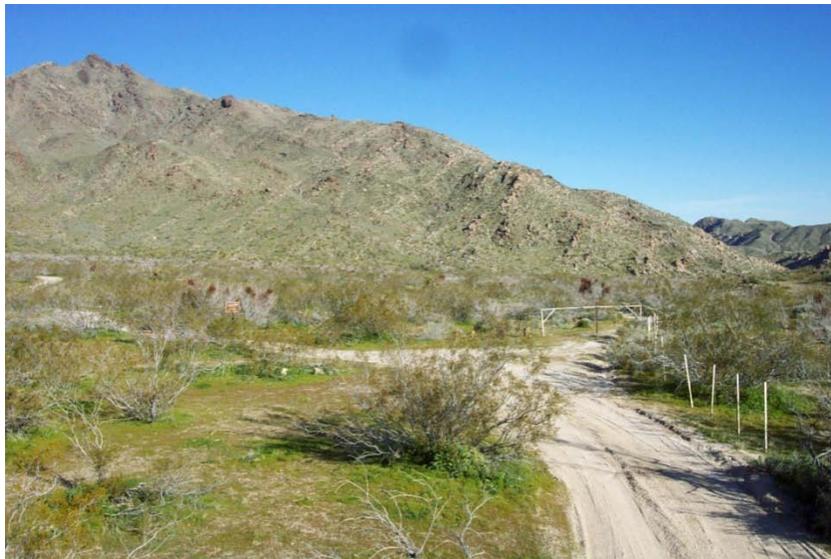
AR 020A - Pipe Spring Rd

Picture of the end of AR 20A

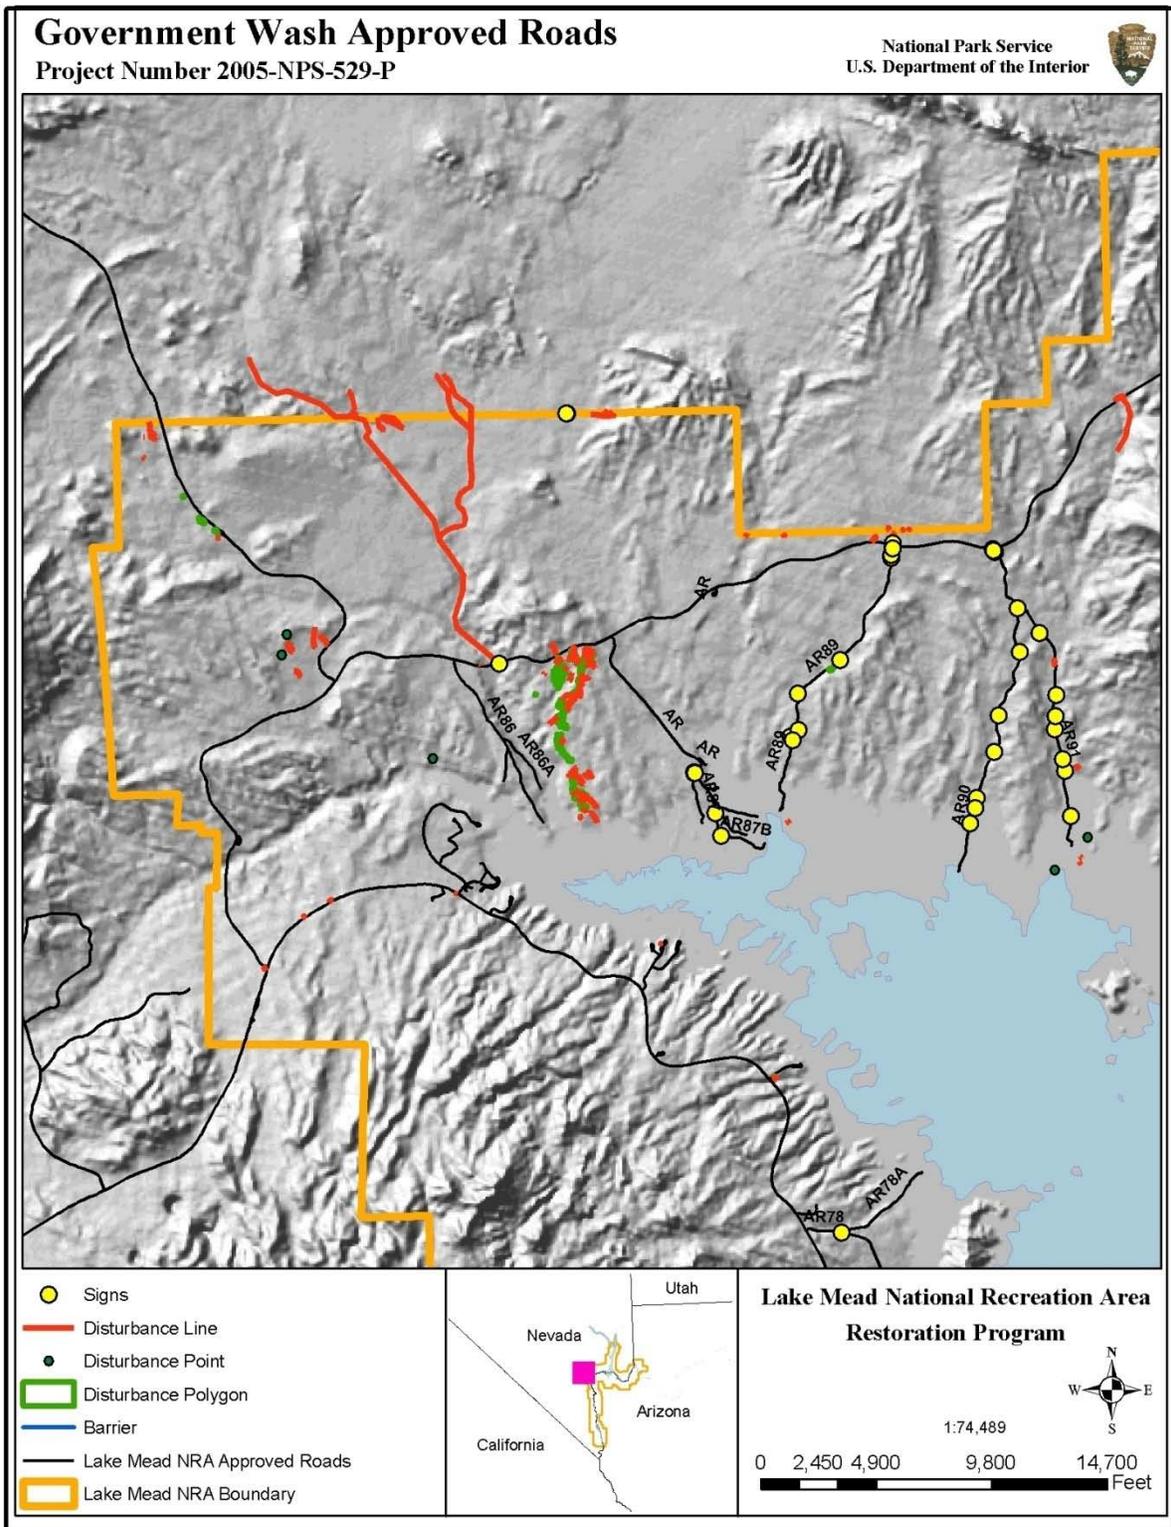
Figure 7. Map of Government Wash Region's Disturbances and Approved Roads

AR 90 (Crawdad Cove Road) is located in the Government Wash area. During the winter, it is a popular area for camping. During the summer before the water in Lake Mead receded, this was a popular swimming location. Nine disturbances were recorded on this road. Most of the disturbances were below the high water mark where a network of user created roads had been established. In the winter of 2009, tank traps were installed along the road to designate a single approved route among the network of roads created by visitors as the water level receded over several years. Maintenance was recruited to fix tank trap breaches during the fall of 2009, and winter of 2010. Most of the tank trap breaches occurred where the tank traps cut off direct access to the old

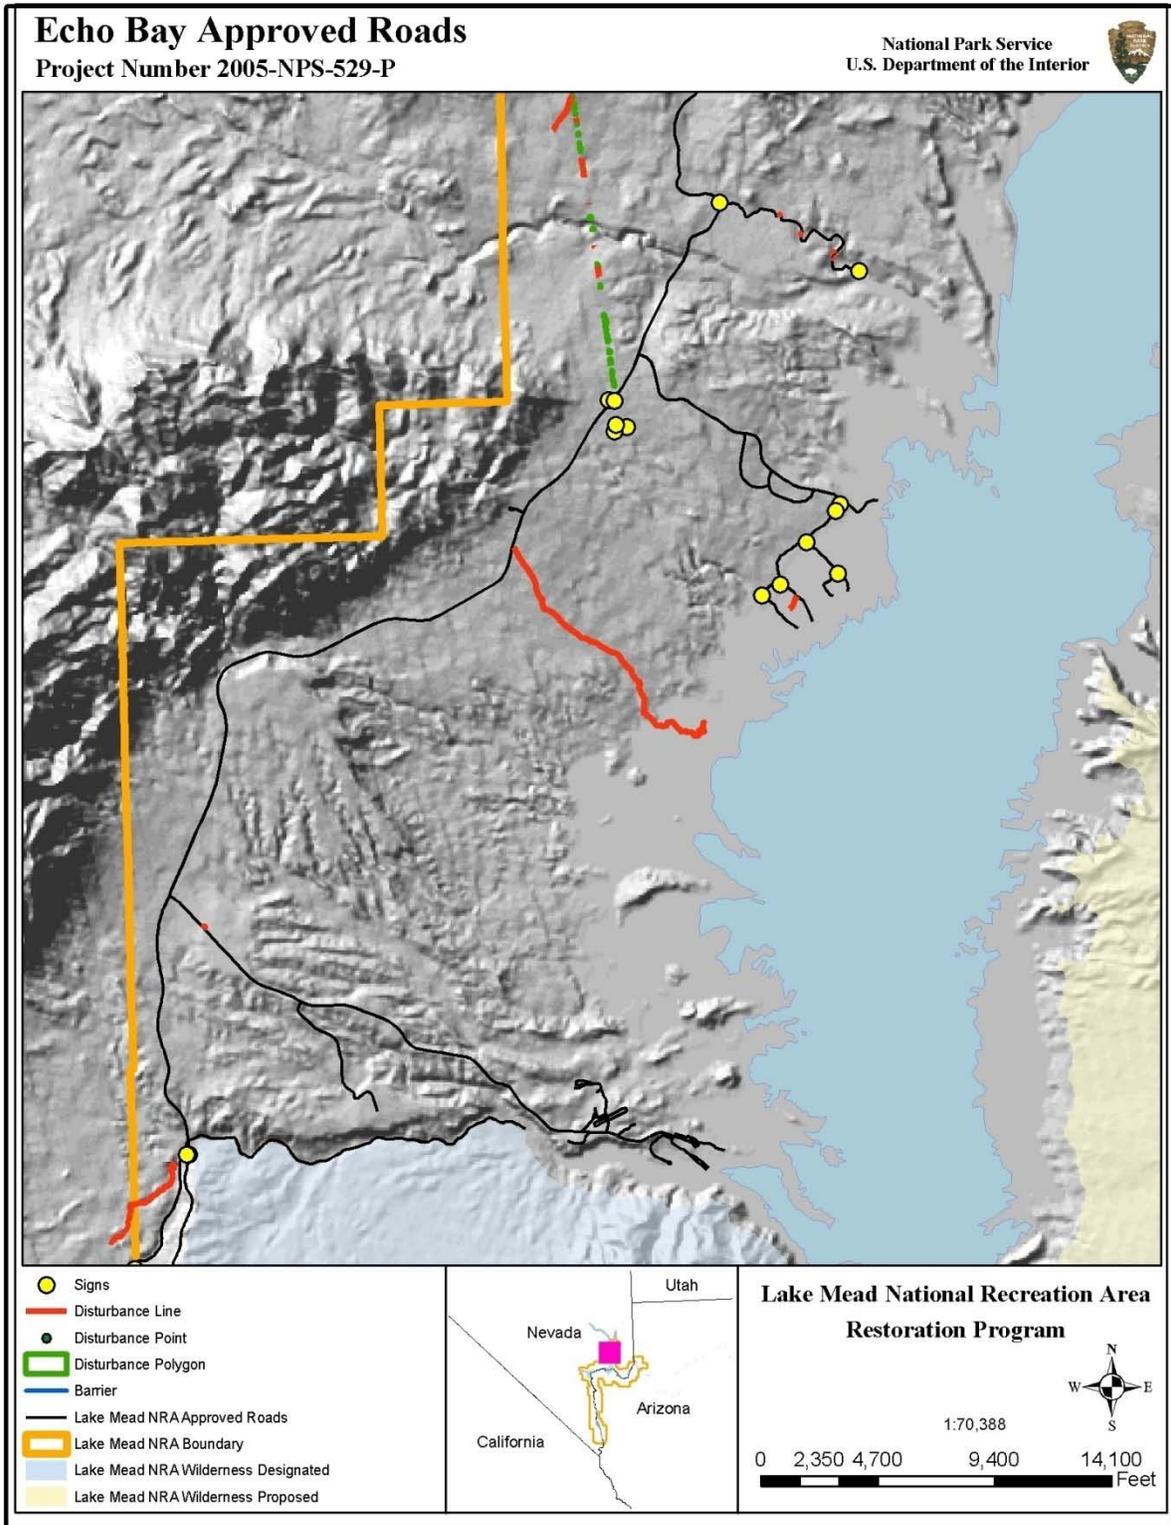
Figure 8. Map of Echo Bay Region's Disturbances and Approved Roads

AR 102 (Echo Wash Road) is located off of Northshore road in the Echo Bay region. The entire road follows a wash to the Echo Bay Marina. During this project, no disturbance was recorded on this road. This road was closed from October 2008 through the end of the project due to the Northshore Reconstruction Project.

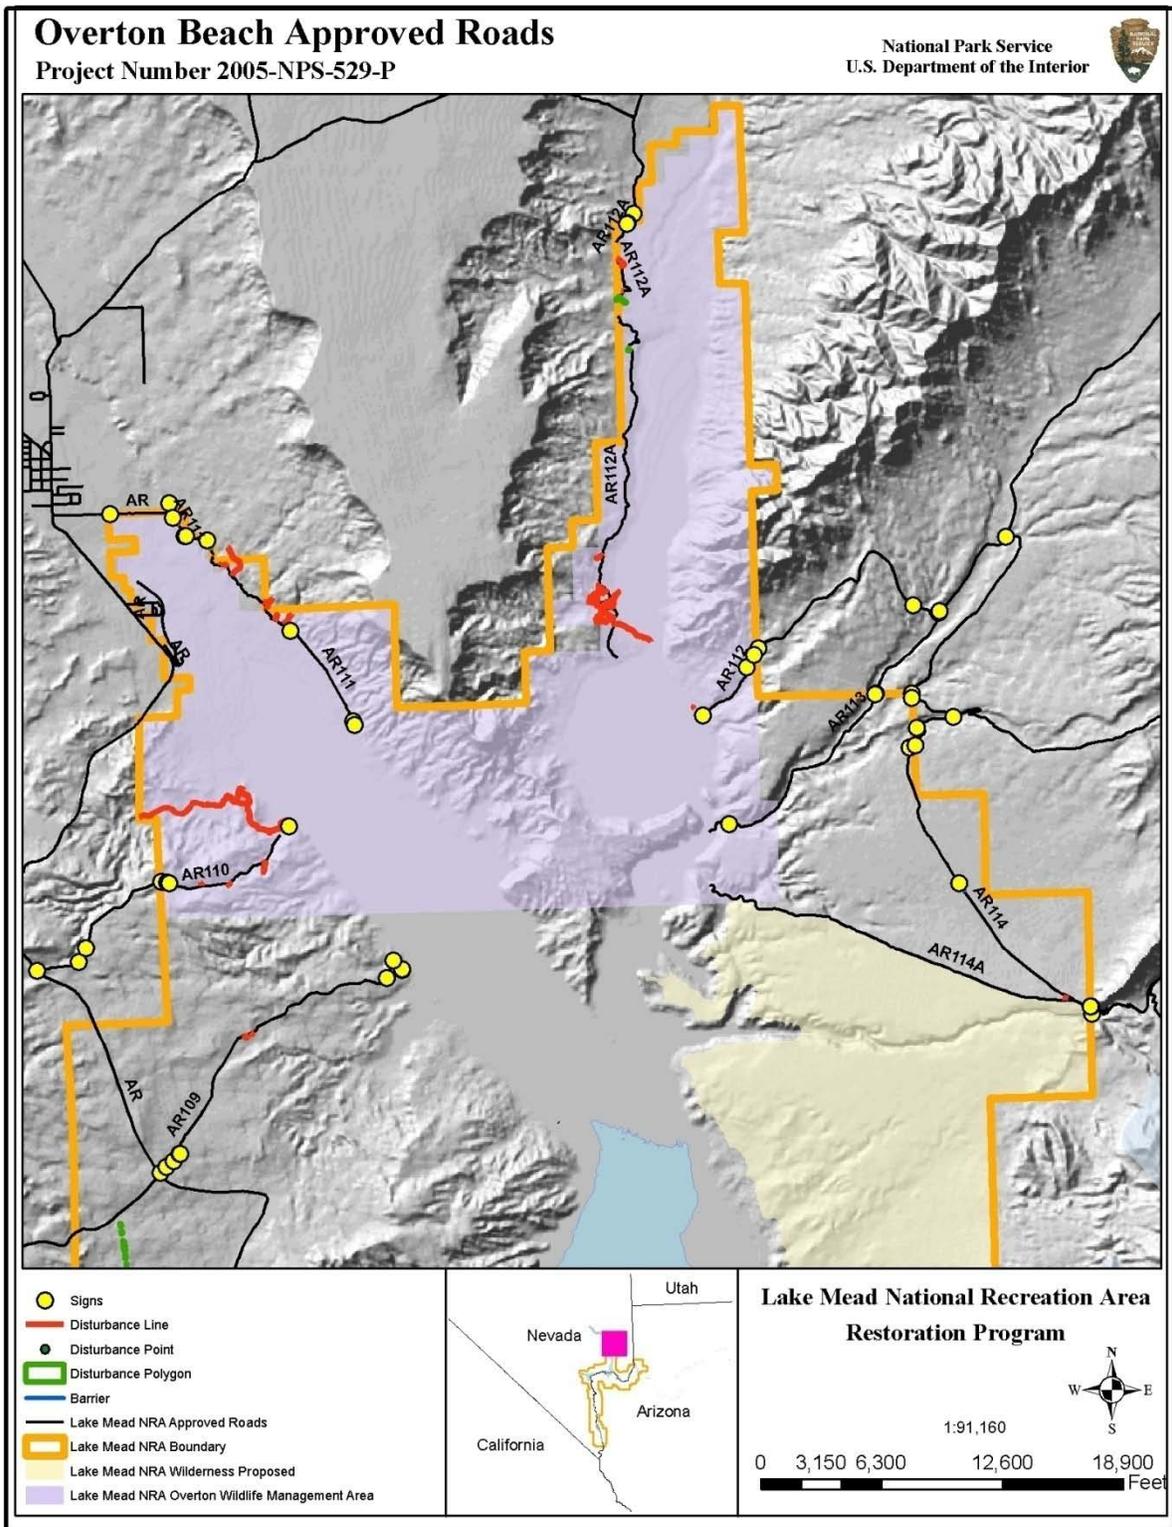
Figure 9. Map of Overton Beach Region's Disturbances and Approved Roads

AR 109 (Old St. Thomas Road), AR 109A (Old St. Thomas Road A), and AR 109B (Old St. Thomas Road B) are roads that lead to St. Thomas Point. AR 109A&B are smaller roads that fork off the end of AR 109. AR109 is located off of Northshore road across from the Valley of Fire road and provides access to popular hiking trails. Several times during this project the road was closed either due to the Northshore Reconstruction Project or because the road washed out from rainfall. One disturbance was recorded between AR 109A and AR 109 B. Nine disturbances were recorded on AR 109. The majority of the disturbances on this road were in the middle section where SUVs or trucks tried to get around the powerline access road gate, damaging sensitive biological soil crusts.

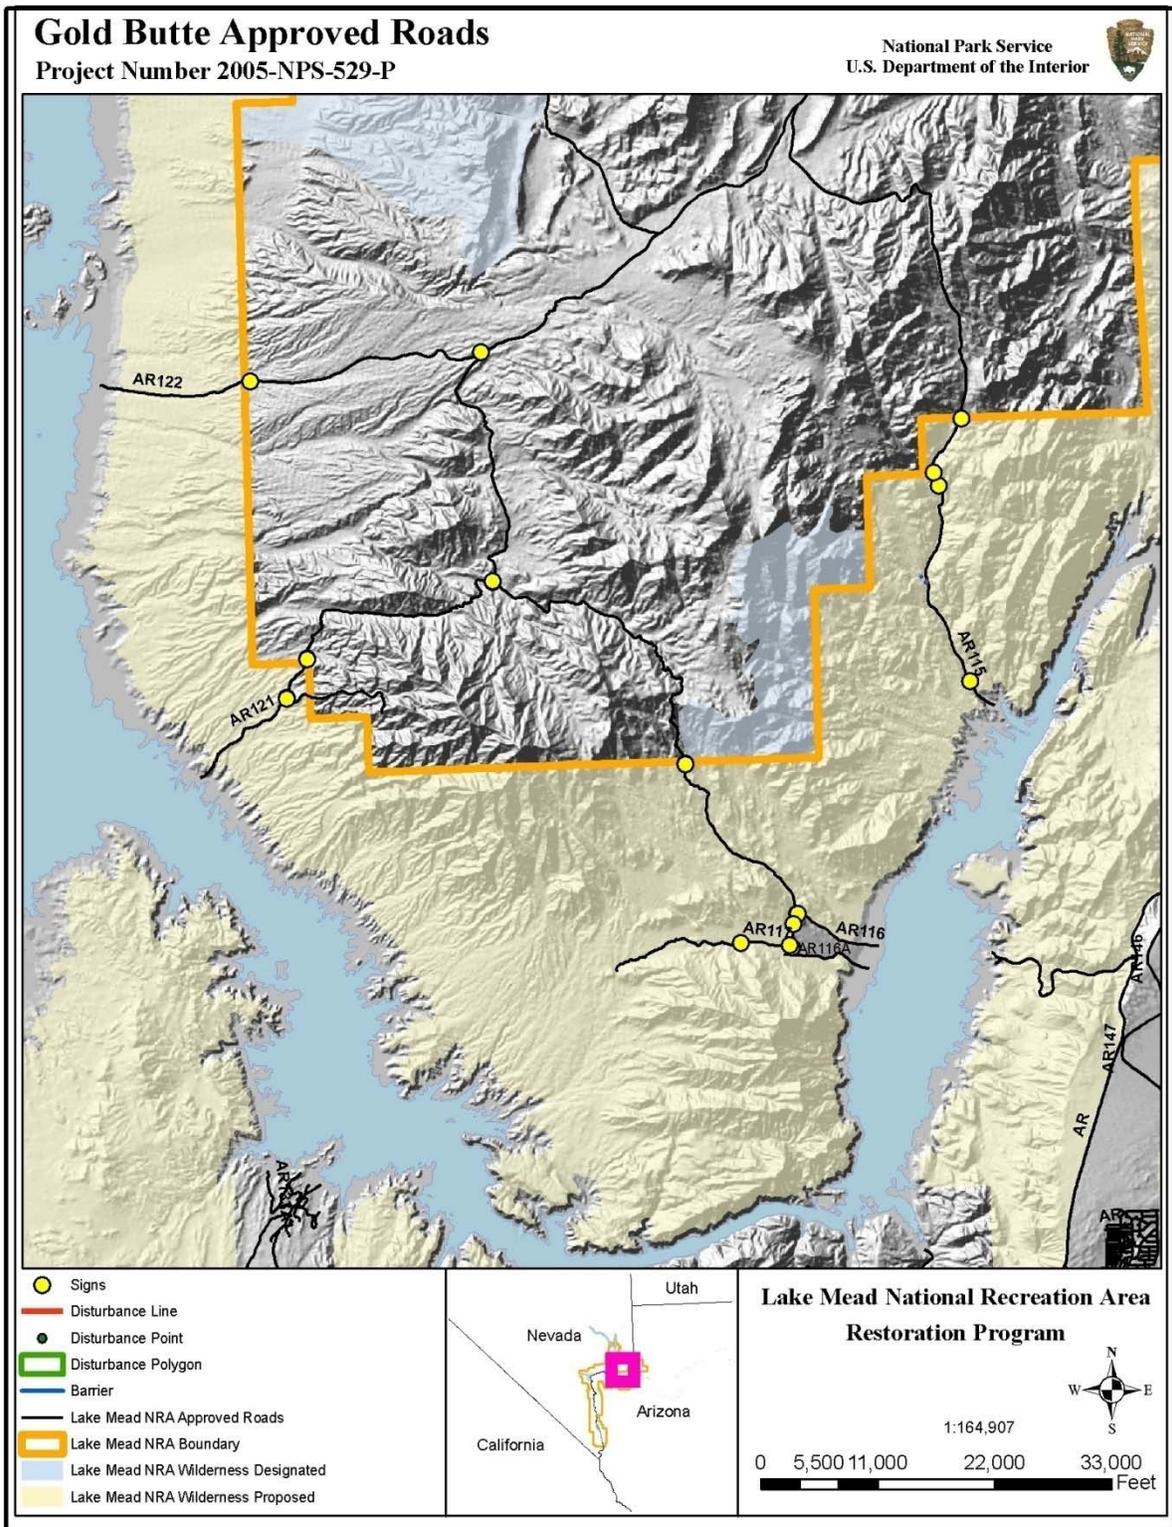
Figure 10. Map of Gold Butte Region's Disturbances and Approved Roads

AR 115 (Devil's Cove Road) is a road in the southern section of Gold Butte. This road starts out as a wide, graded road and turns into a difficult 4x4 road that follows a wash to where the Colorado River meets Lake Mead. This road used to be a take out spot for people traveling down the Colorado River, but since the water has receded, visitors prefer to take out at Pearce Ferry. This road mainly received ATV use, especially during the hunting season. Four disturbances were recorded on AR 115. The major issue along this road was an illegal route connecting AR115 with a BLM road. This illegal route traveled northwest off of AR115 from the middle section of the road into a proposed wilderness area. The restoration crew installed two barriers along this illegal route to prevent off-road activities. For several months after the barrier installation, the restoration crew would regularly have to re-install posts or tighten the barriers' cable. Before the BLM installed a barrier on their end of the illegal route, it appeared that visitors would travel down the illegal road from the BLM side, reached the NPS barriers and instead of turning around would tear the barriers out of the ground. After the BLM installed a barrier on their end of the illegal route, the NPS barrier did not get disturbed as often. This road frequently washed out, which changed the location of the road. This natural re-locating of the road would sometimes result in signs no longer being along the travelled route.

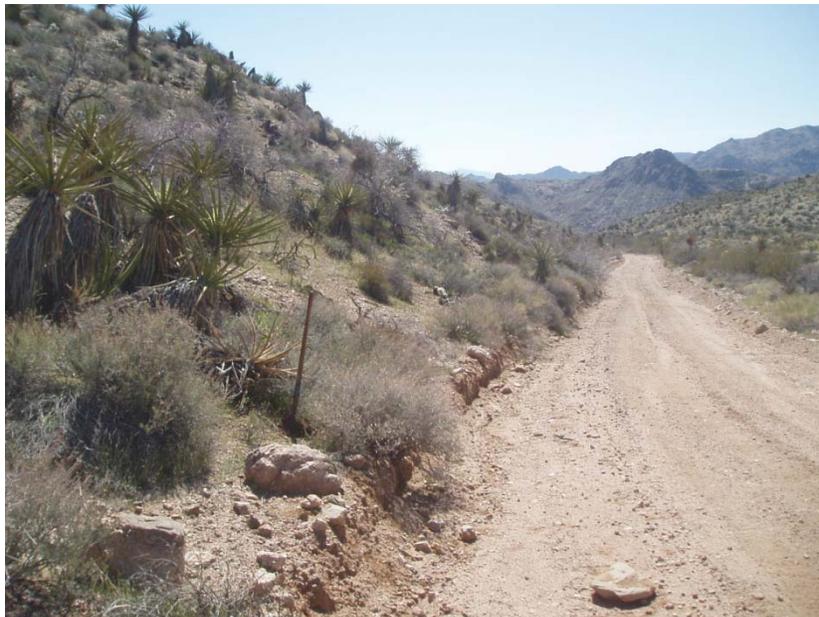
AR 115 - Devils Cove Rd

Picture looking south down AR 115 near park boundary
