Gold Butte AML Closures 2017-NDM-1792C Final Project Report

2017-NDM-172C

Desert Conservation Program

November 11, 2019

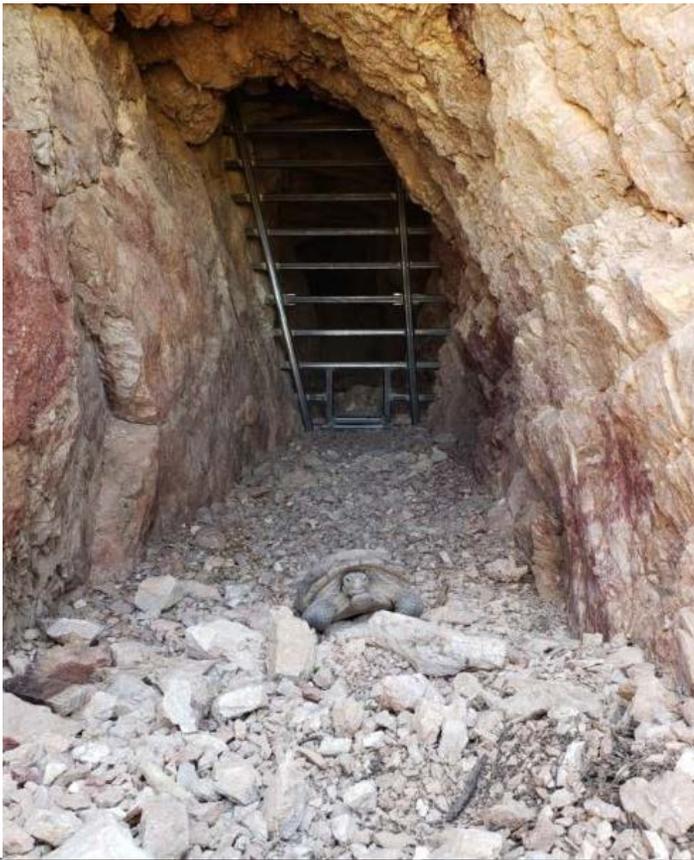
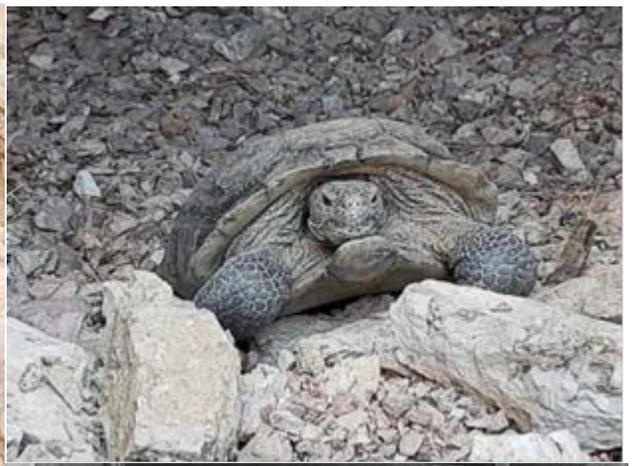
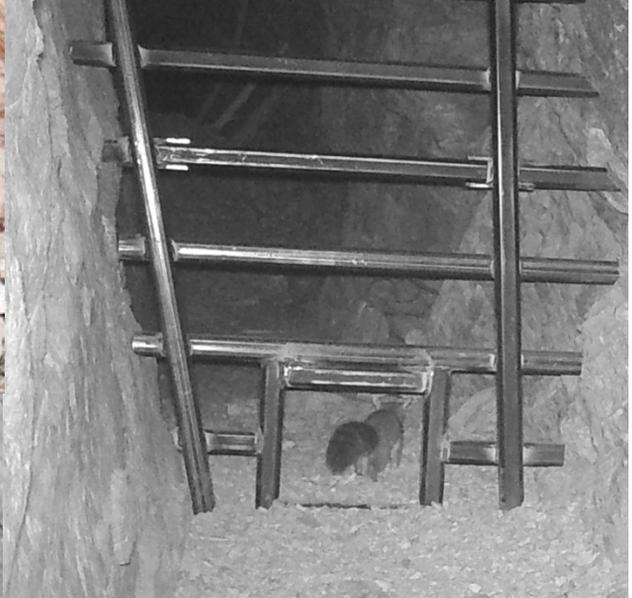
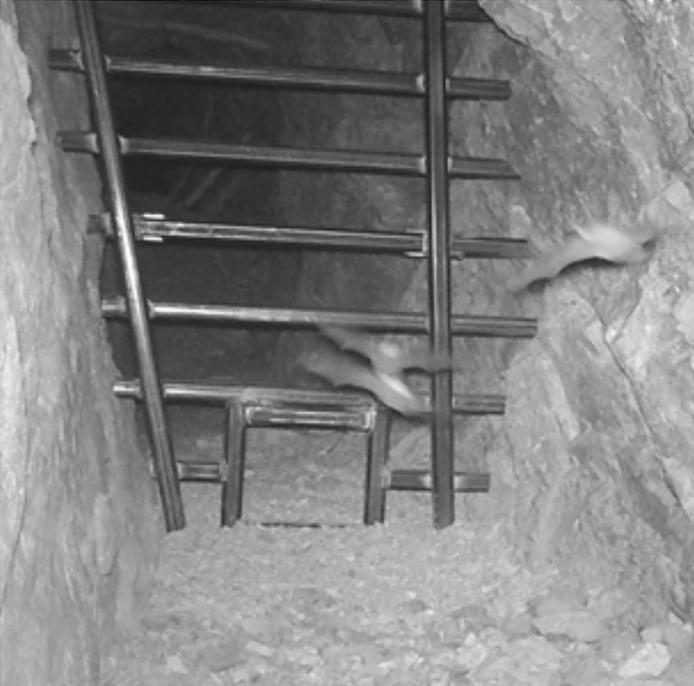
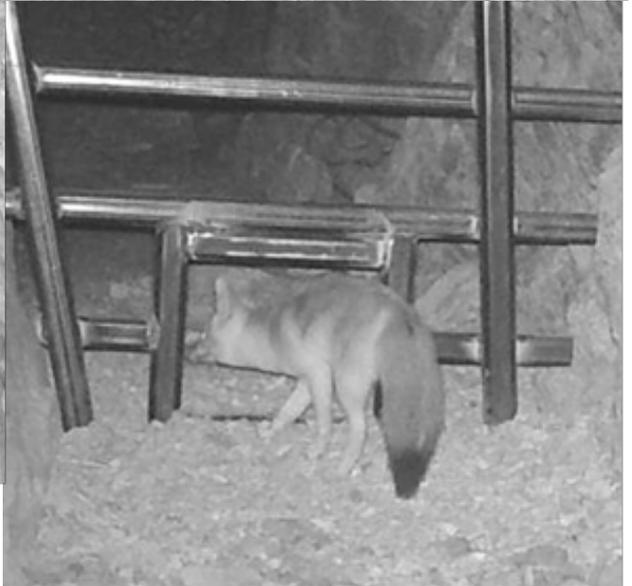
Photos of Desert Tortoise, Bats, Gray Fox, and a Ring-tailed cat using the gate in Gold Butte National Monument

NDOW used a game camera on one hazard that was noted to have a tortoise exit the mine after the gate was constructed. The game camera not only captured the use of this mine by bats, but also a small gray fox and a ring tale cat. The camera was only up for a short period of time and did not capture the tortoise re-entering the mine but further evaluations of the gate will be conducted of the next few years. Below is a list compiled by NDOW of wildlife that can use mines for habitat:

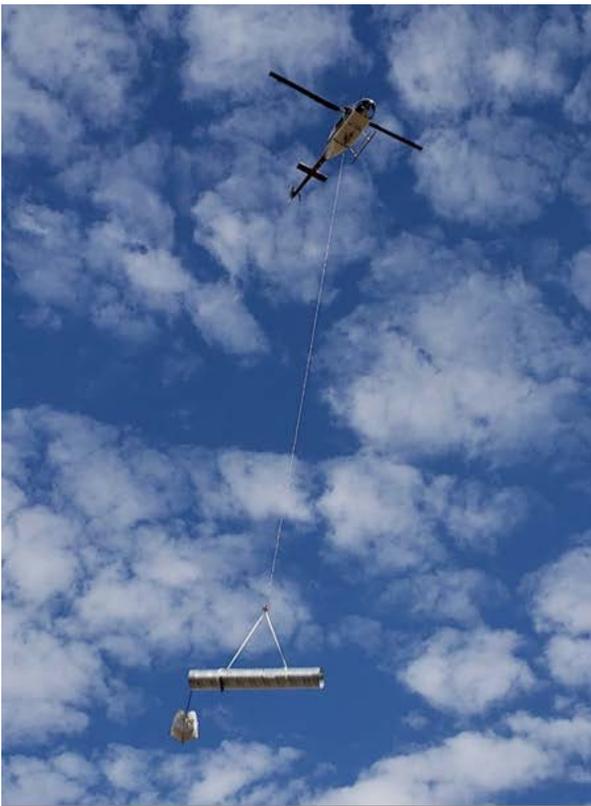
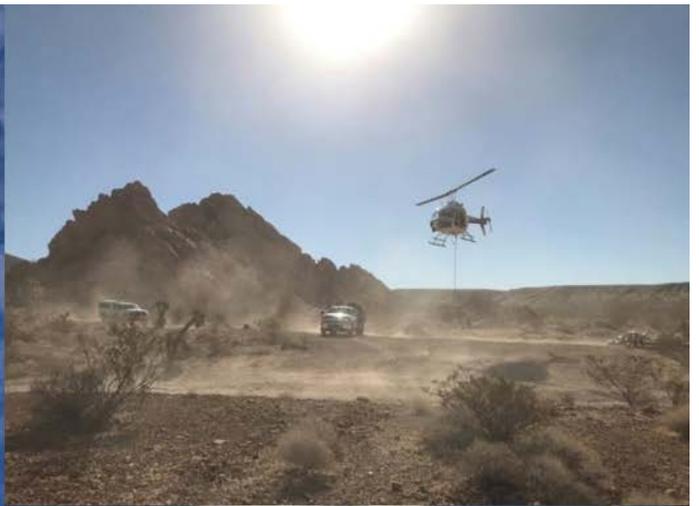
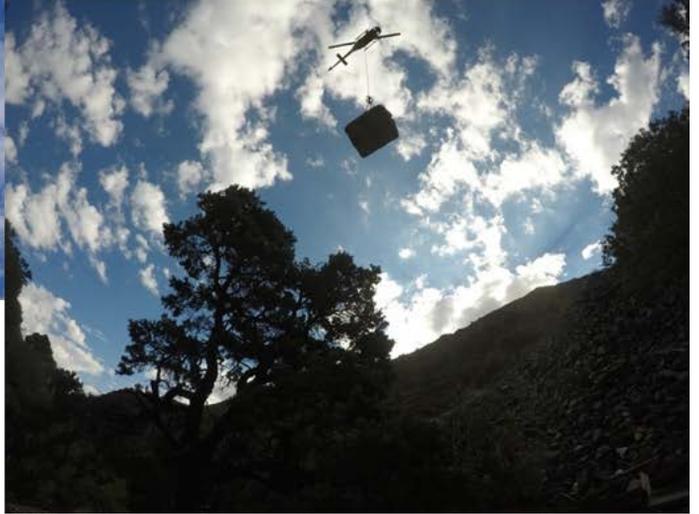
Left: Helicopter transporting a culvert using a super sack bag creating drag reducing spin during transport
Top Right: Materials staging area
Bottom Right: The helicopter delivering materials in the Virgin Mountains

Majority of the mines were not accessible by road requiring the use of a helicopter to sling load the metal for the gate and all welding and cutting equipment needed to construct the gate inside the portal. The use of helicopter not only reduced the footprint of the contractor by removing all overland travel, but also reduced the project time resulting in a net reduction on the project cost.

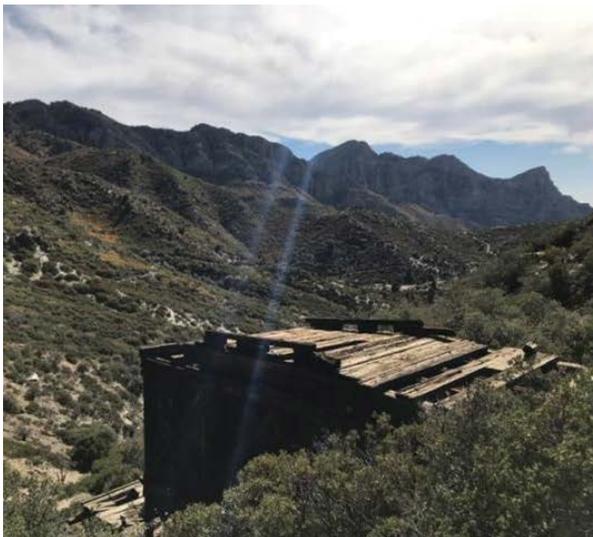
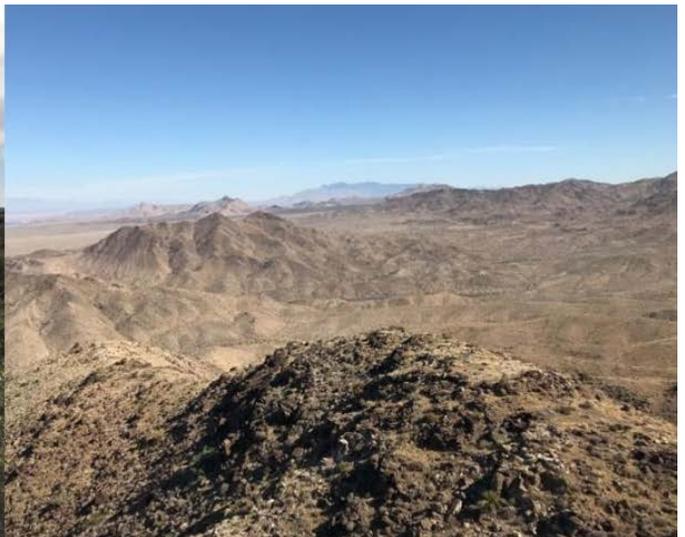
Left: An ore loadout associated with a hazard in the Virgin Mountains
Right: A view looking north from the southernmost hazard in the project with the Virgin Mountains in the far horizon showing the vast distance between hazard sites within the Gold Butte project

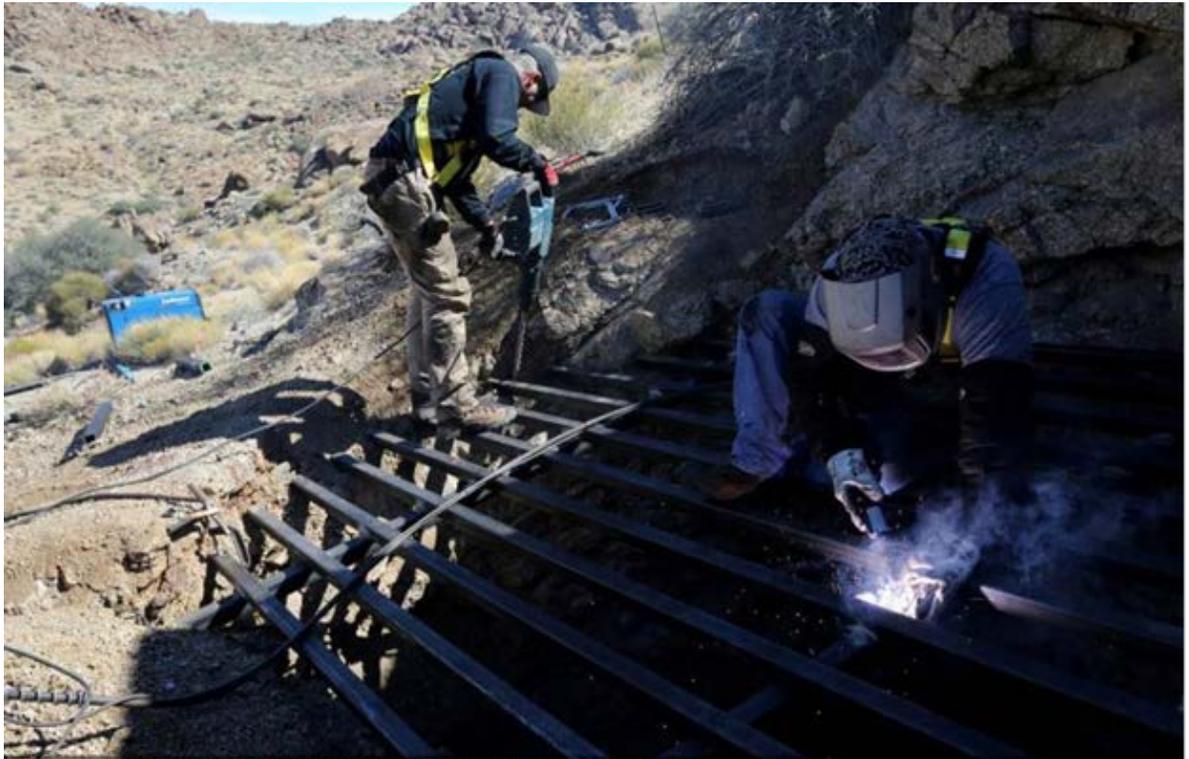
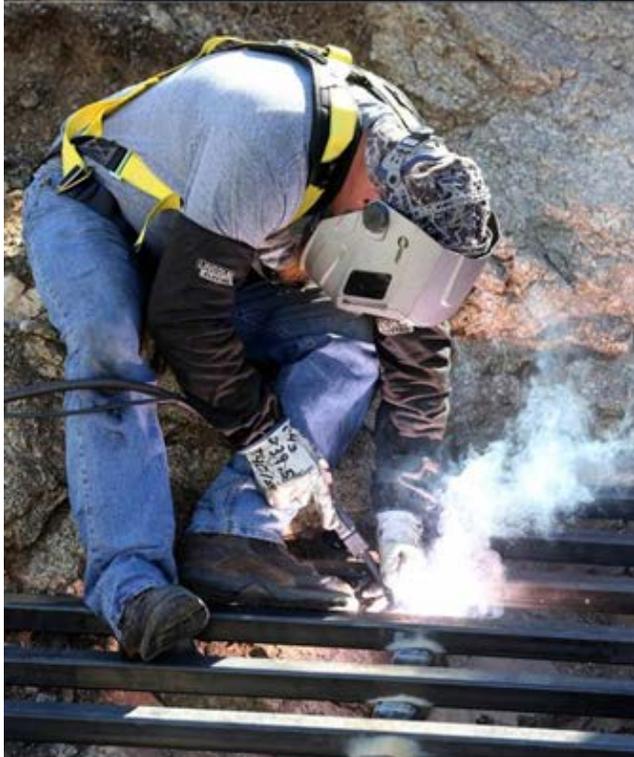
Photos captured by the Las Vegas Review Journal during their site visit. The grate across this shaft being welded by an EPS employee was located near the ghost town of Gold Butte.

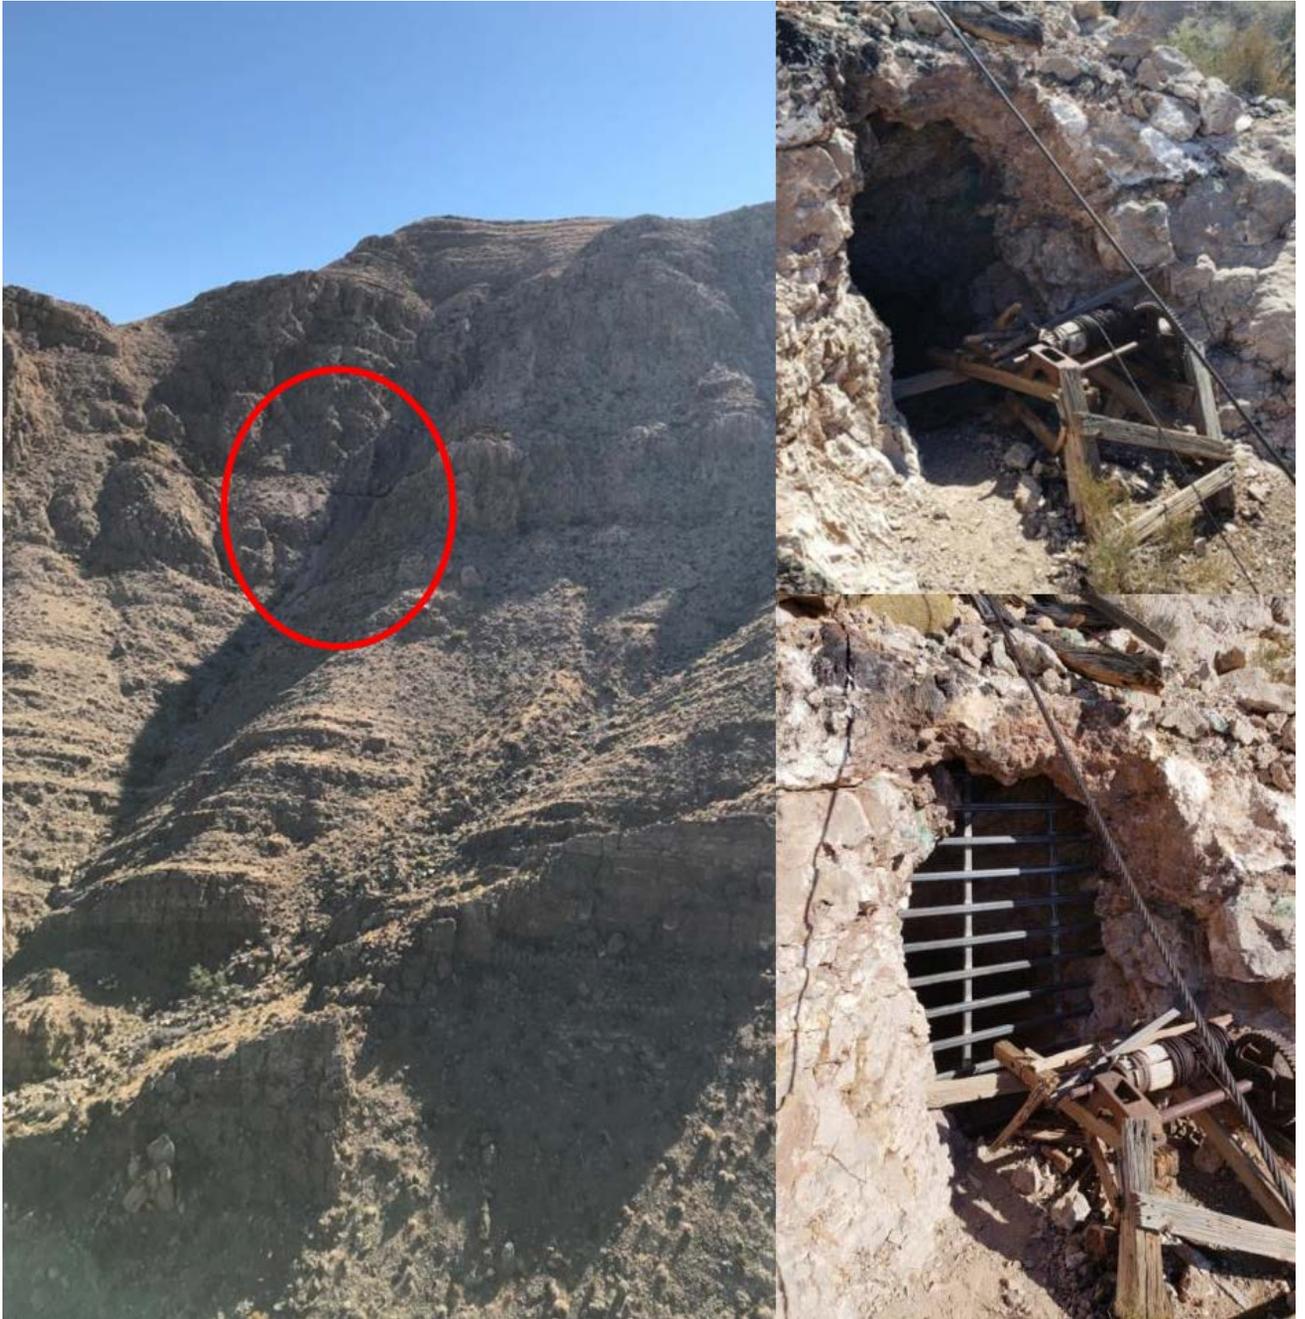
The Tramp Complex apart of the Gold Butte Project: although remote, an established unofficial hiking trail was used to hike personnel to the site after the materials were dropped off by the helicopter. The before and after photos on the right illustrates how EPS was able to construct a wildlife gate without impacting the cultural resources.

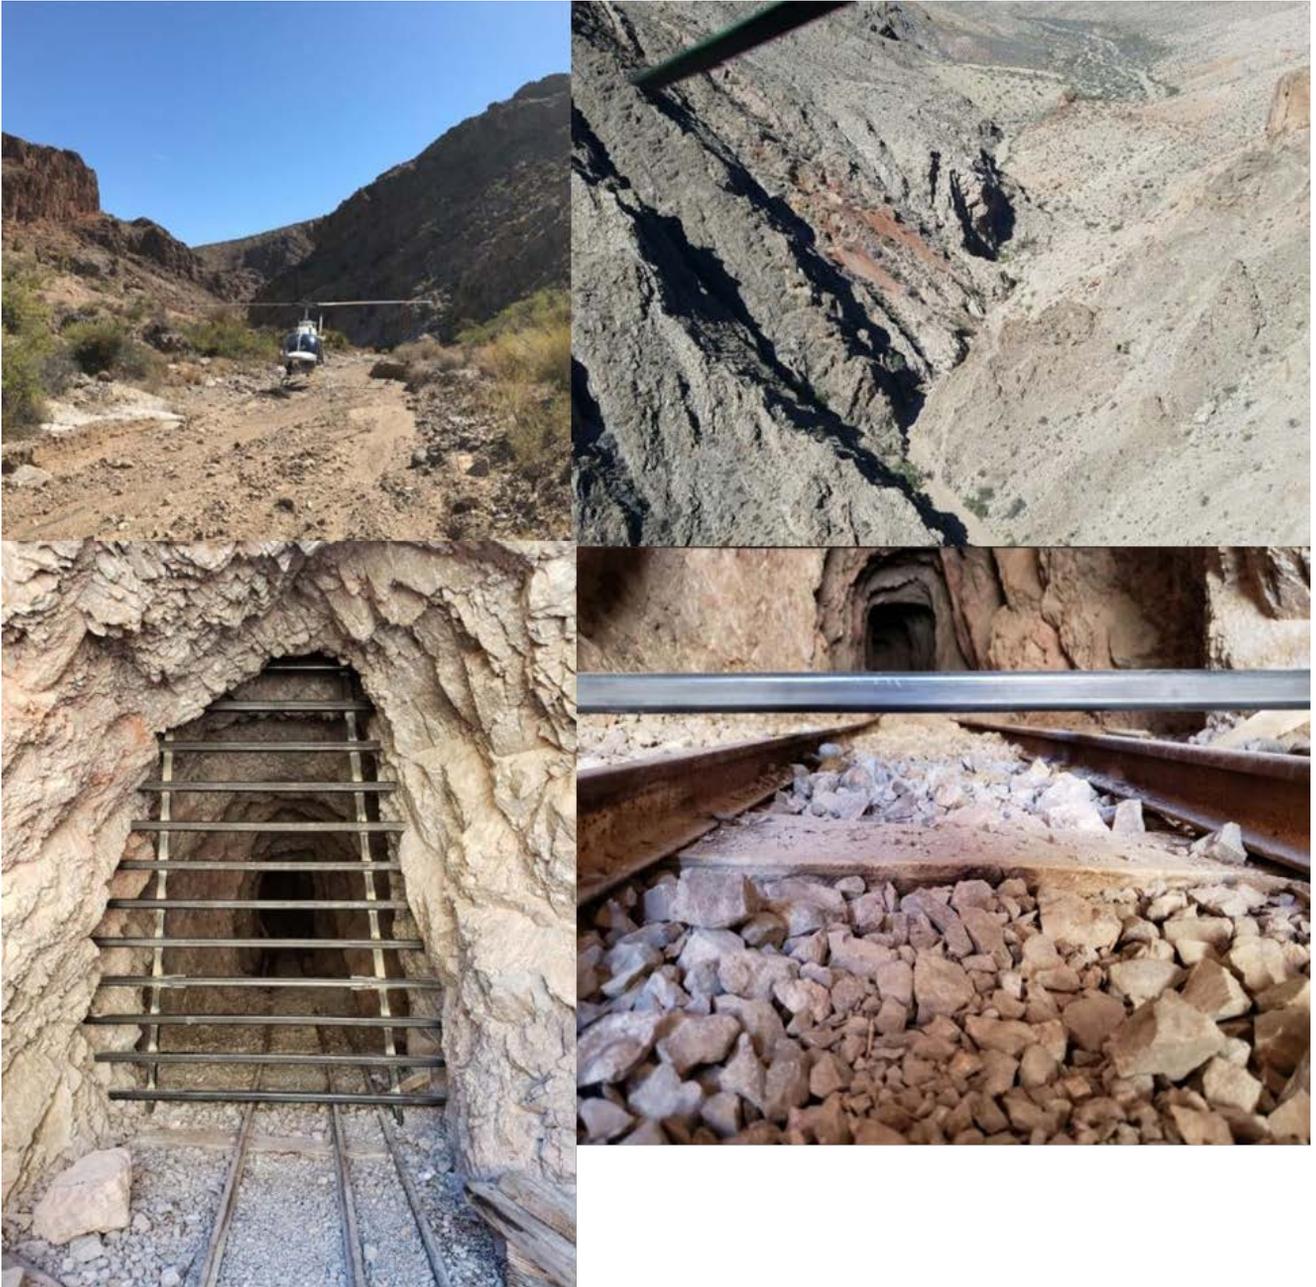
The Azure Ridge Complex apart of the Gold Butte Project. Located inside a wash that leads to a slot canyon, the Azure ridge complex consisted of two open adits, one caved adit, and one caved shaft. A road led to the mouth of the wash upstream from the complex but had been washed out by years of flash flood rains. Just past the mine complex, a BLM sign was still intact warning four-wheelers of the slot canyon and not to proceed past that point. The haulage adit received a bat gate and EPS was able to construct the gate without impacting the rails. What the photos do not show is that EPS was able to dig underneath the rails without impacting them, insert a bar below on the bedrock and then bury the bar so no one could dig underneath the bars to gain entry.

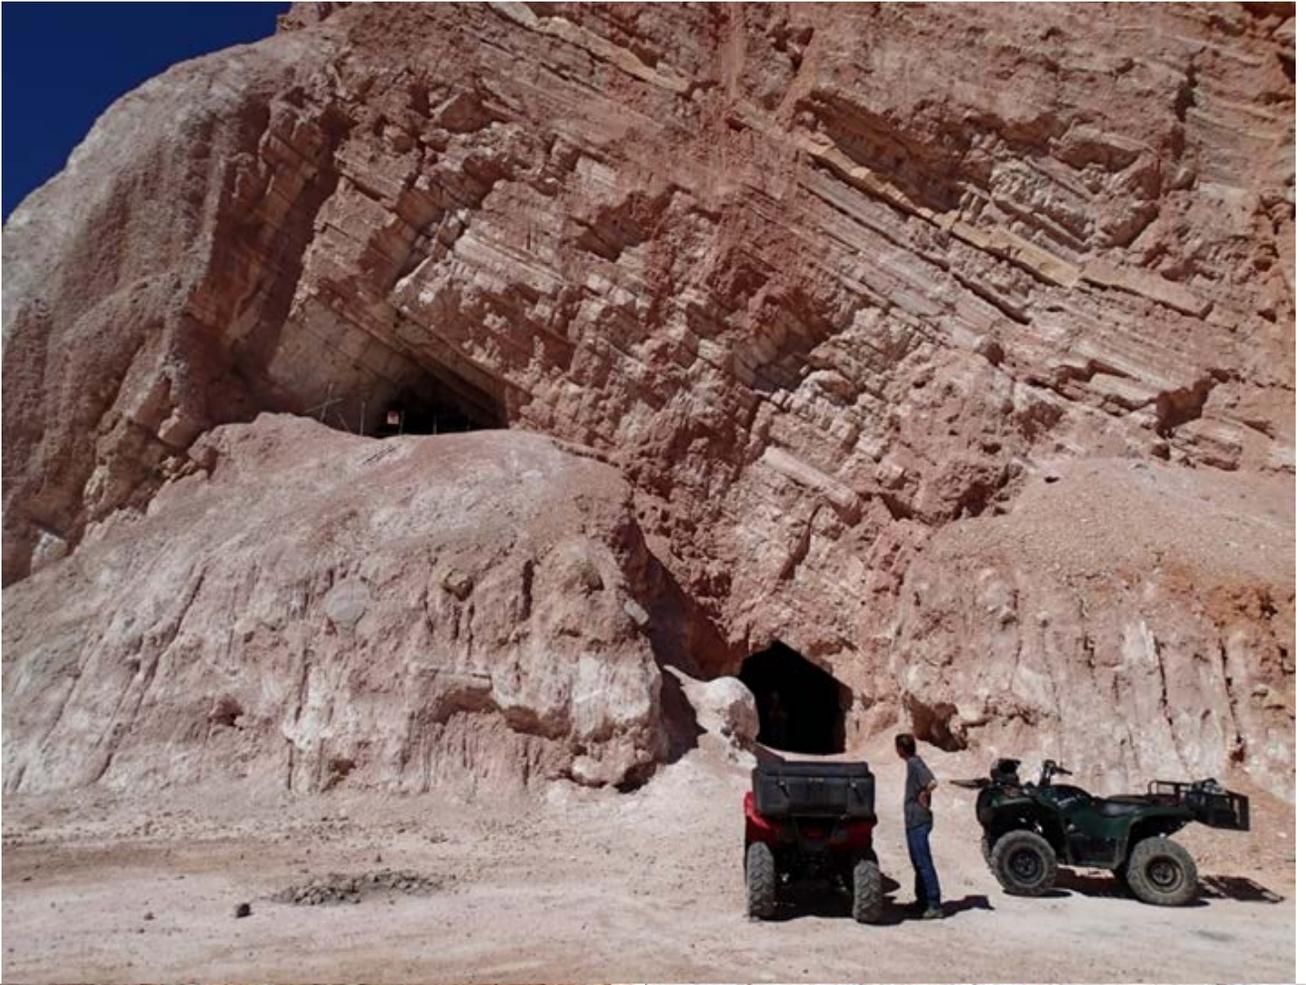
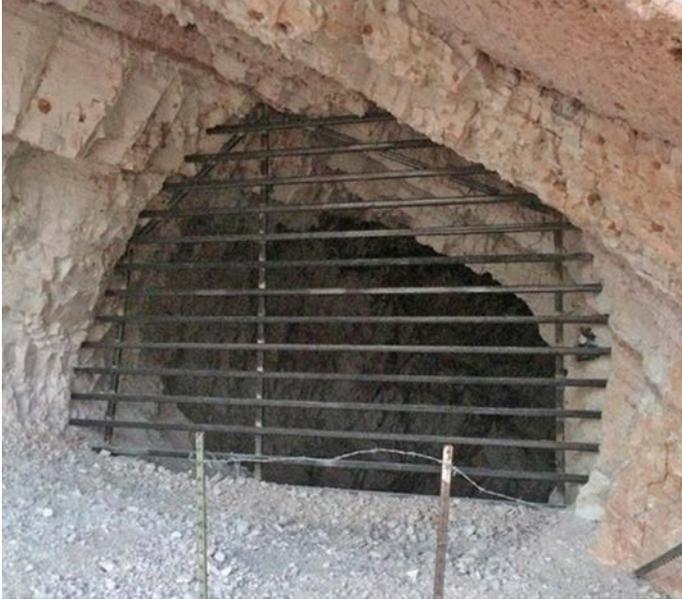
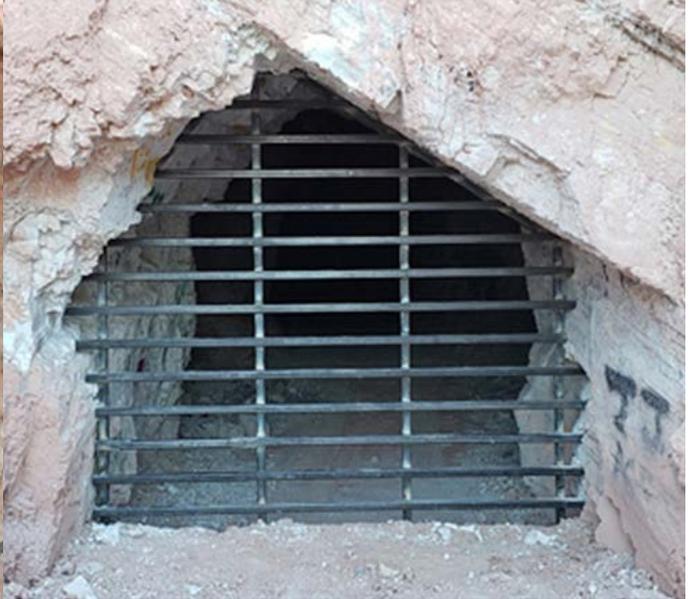
Gates at the Magnesite Mine Complex a the Valley of Fire State Park

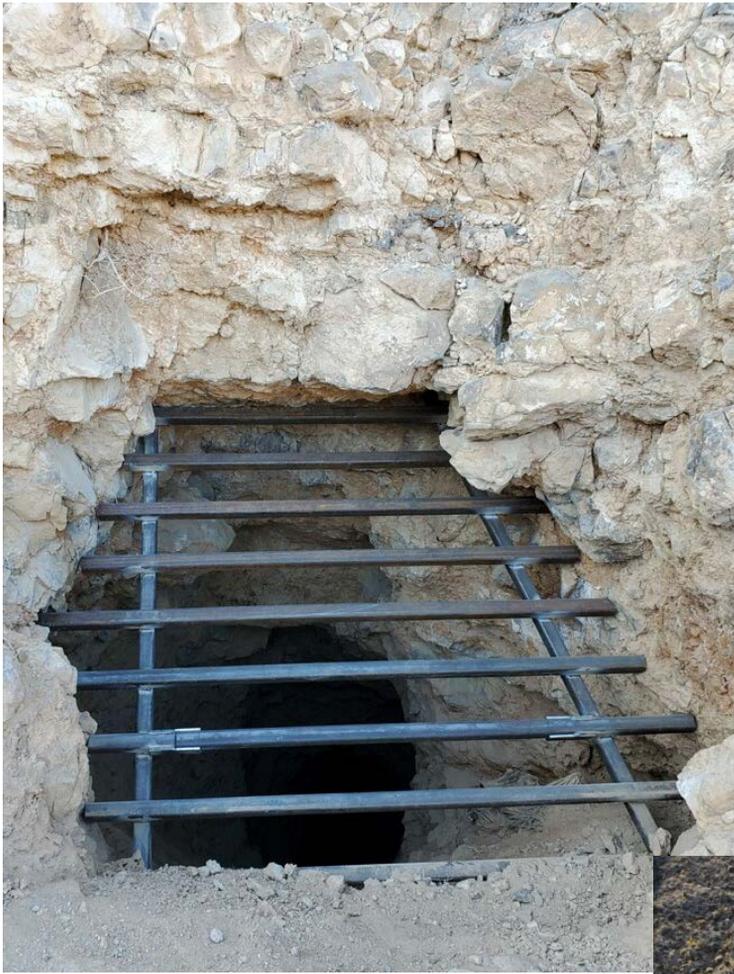
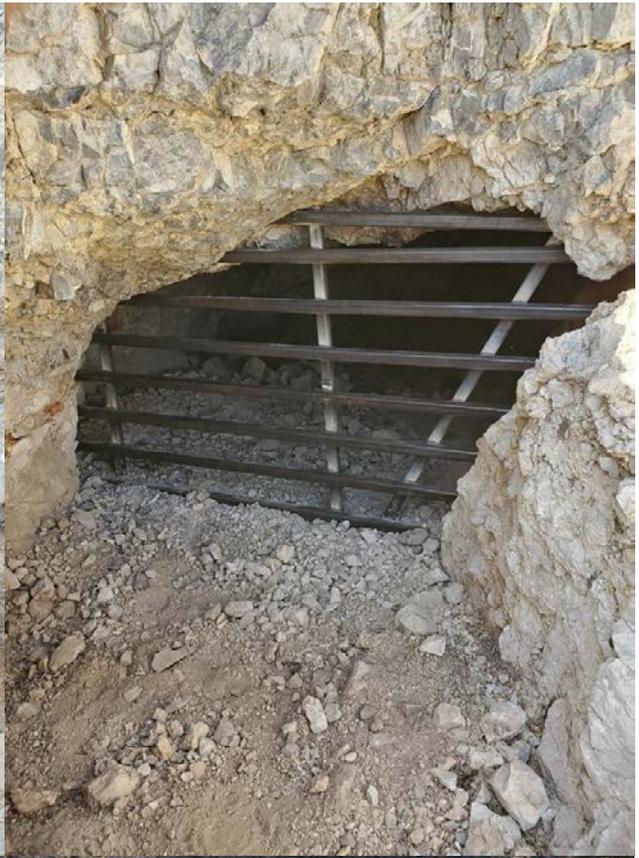
Two completed gates and a small materials landing zone for hazards at the Goodsprings project
