Using a Geotechnical Assessment to Guide Riparian Restoration, Muddy River Reserve

CCDCP Symposium Las Vegas, NV August 13, 2015 Glen Leverich – Stillwater Sciences Bruce Orr – Stillwater Sciences Elizabeth Bickmore – CCDCP

CCDCP MUDDY RIVER RESERVE GEOTECHNICAL ASSESSMENT

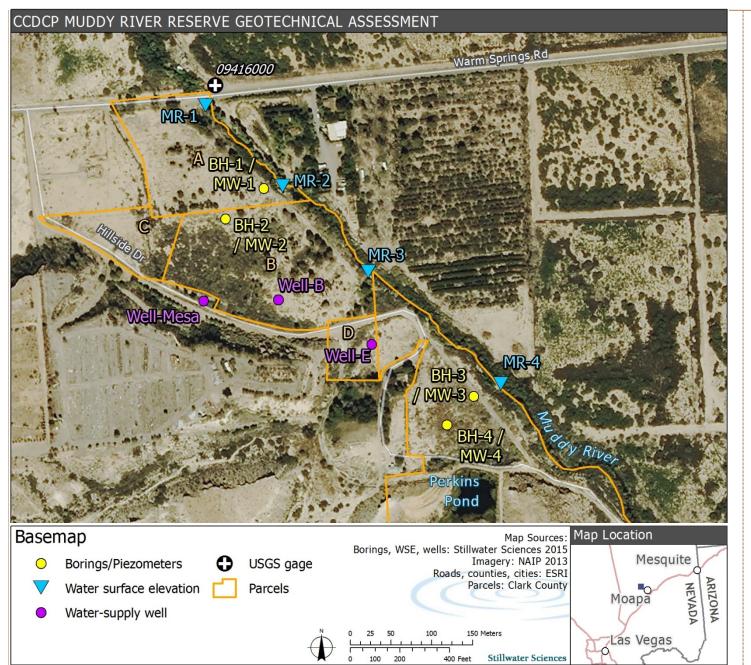
Location

Muddy River Reserve Parcels A, B, and E

A: 4.9 ac B: 3.0 ac E: 25 ac

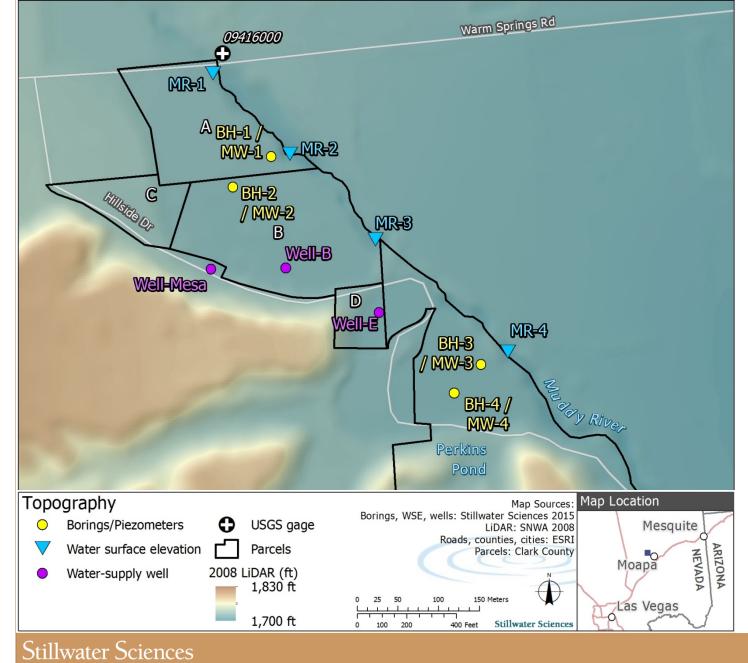
Topography

Lidar from 2008 (SNWA)

Flat floodplain

Incised channel, ~15 ft below floodplain (field observation)

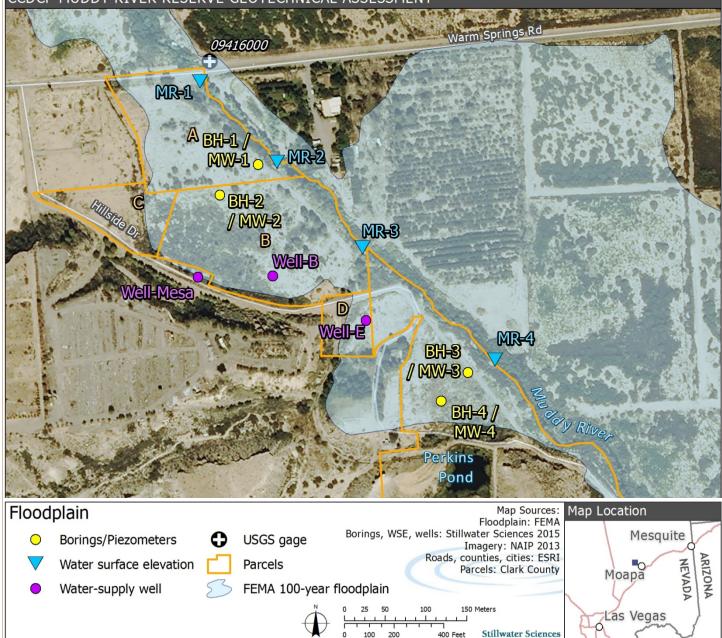
Hydrology

4–8 in annual average rainfall

Perennial flow from upstream springs

Consistent flows, ~40 cfs

Flashy floods (*e.g.*, 9/27/2014 = 3,320 cfs [~38-yr return period])

100-year floodplain (FEMA)

Assumed shallow groundwater

Recently scoured wash channel on Parcel E (photo taken 10/31/2014 by B. Orr)

Recently accumulated sediment and woody material in river channel below wash near Parcel E (photo taken 10/31/2014 by B. Orr)

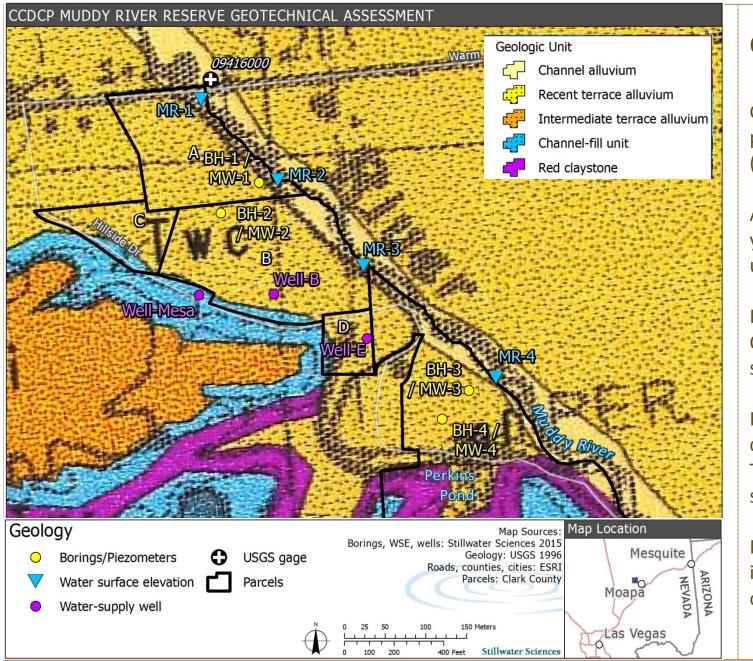
Geology

Geologic mapping published in 1996 (USGS)

Area composed of young sedimentary units

River composed of Channel Alluvium: silts, sands, gravels

Floodplain composed of Terrace Alluvium: silt and sand

Muddy River has incised 10–20 ft over past century

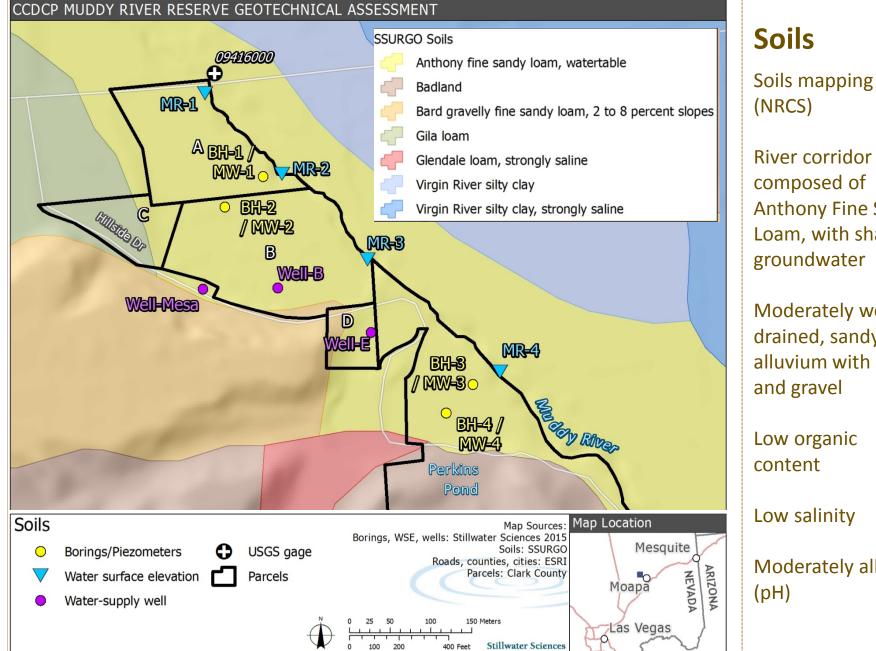
Moderately alkaline

River corridor composed of Anthony Fine Sandy Loam, with shallow groundwater

Moderately well drained, sandy alluvium with clay

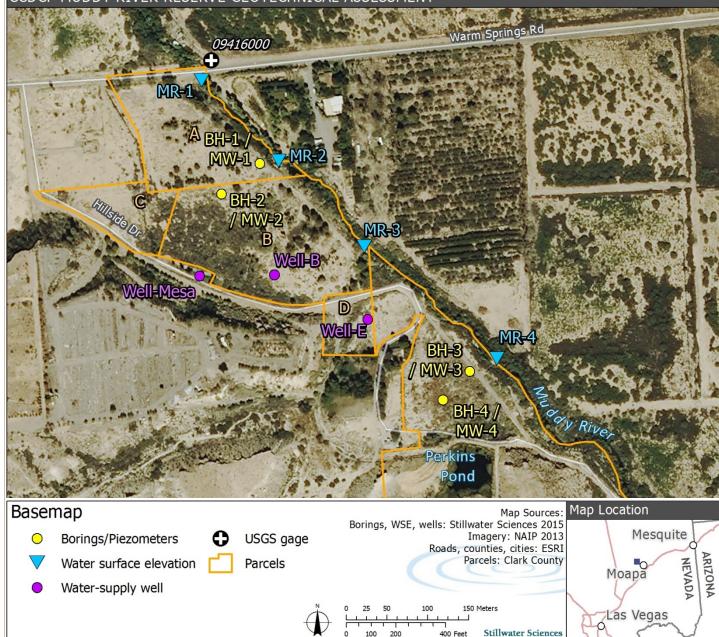
Field Data Collection

4 Boreholes: cored 20–25 ft bgs

4 piezometers (monitoring wells)

Water-level measurements

Surveyed well heads and other points of interest

Geotechnical sample collection of BH-3 / MW-3 on Parcel E (photo taken 5/27/2015 by G. Leverich)

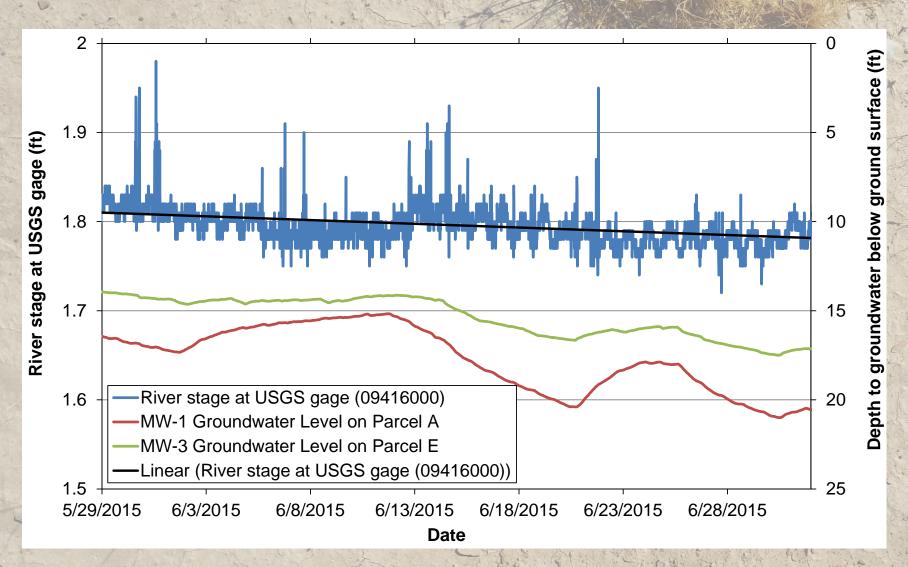
Grading Plan Recommendations for Parcel E

Lowering of the floodplain <10 ft to re-establish hydrologic connectivity with active river channel

Create an arcuate, semi-circle planform shape centered on unnamed wash and sloped toward river

Grading plan to consider hydro-geomorphic assets (perennial water supply) and hazards (bank erosion)

Alkalinity and salinity of soils may limit planting suitability for some native woody riparian species (e.g., *Populus f., Salix g., Fraxinus v.*), and instead favor other riparian and upland species (e.g., *Baccharis* spp., *Prosopis* spp., *Atriplex* spp.)

Irrigate from local water-supply wells
